Clifton Mill: part 3

The final part of our description is a report on the significance of the mill and the principal features of interest: the photographic survey and report covered only the old Mill: the nineteenth-century addition on the west end has already been converted to a private house.

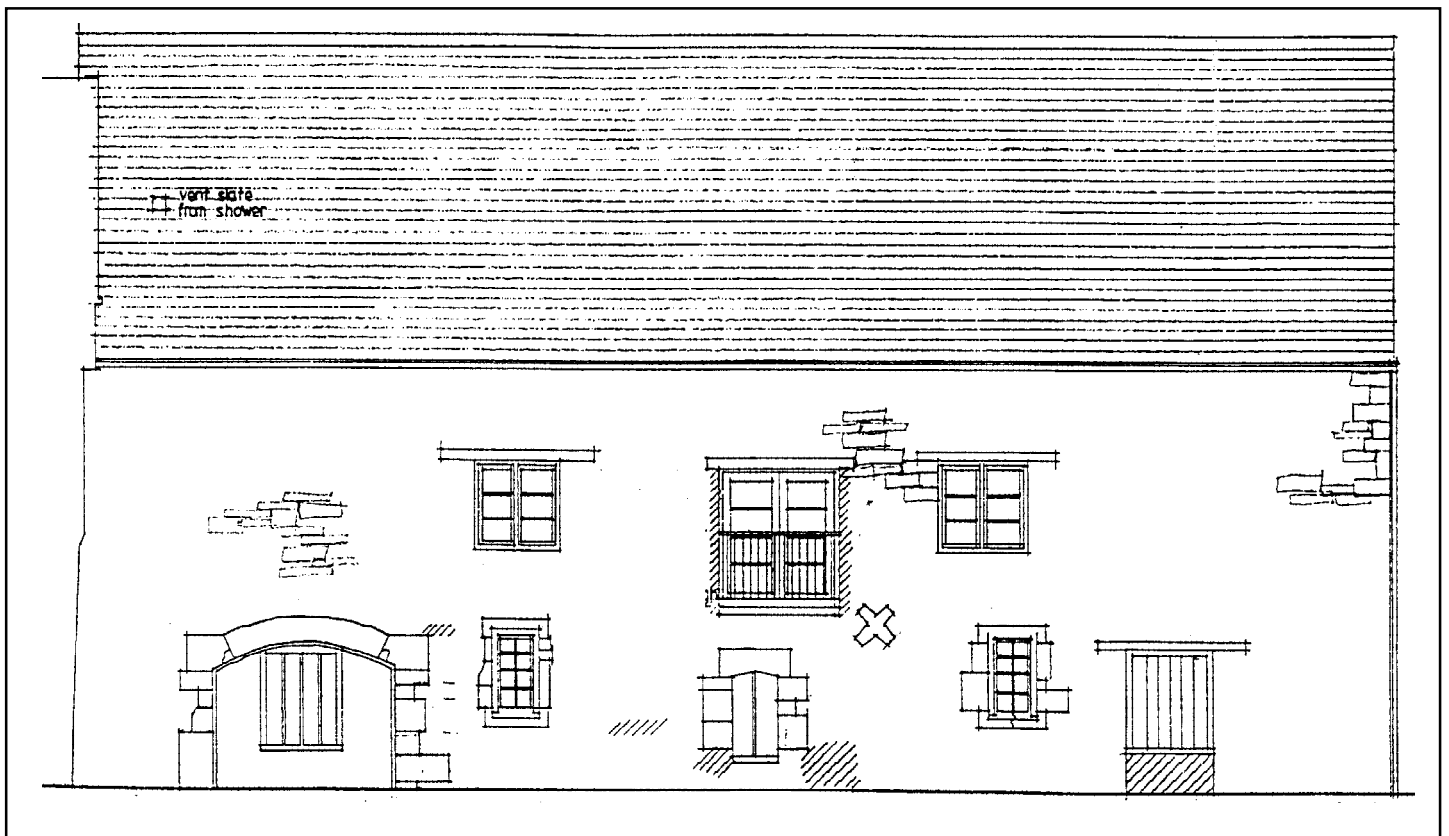
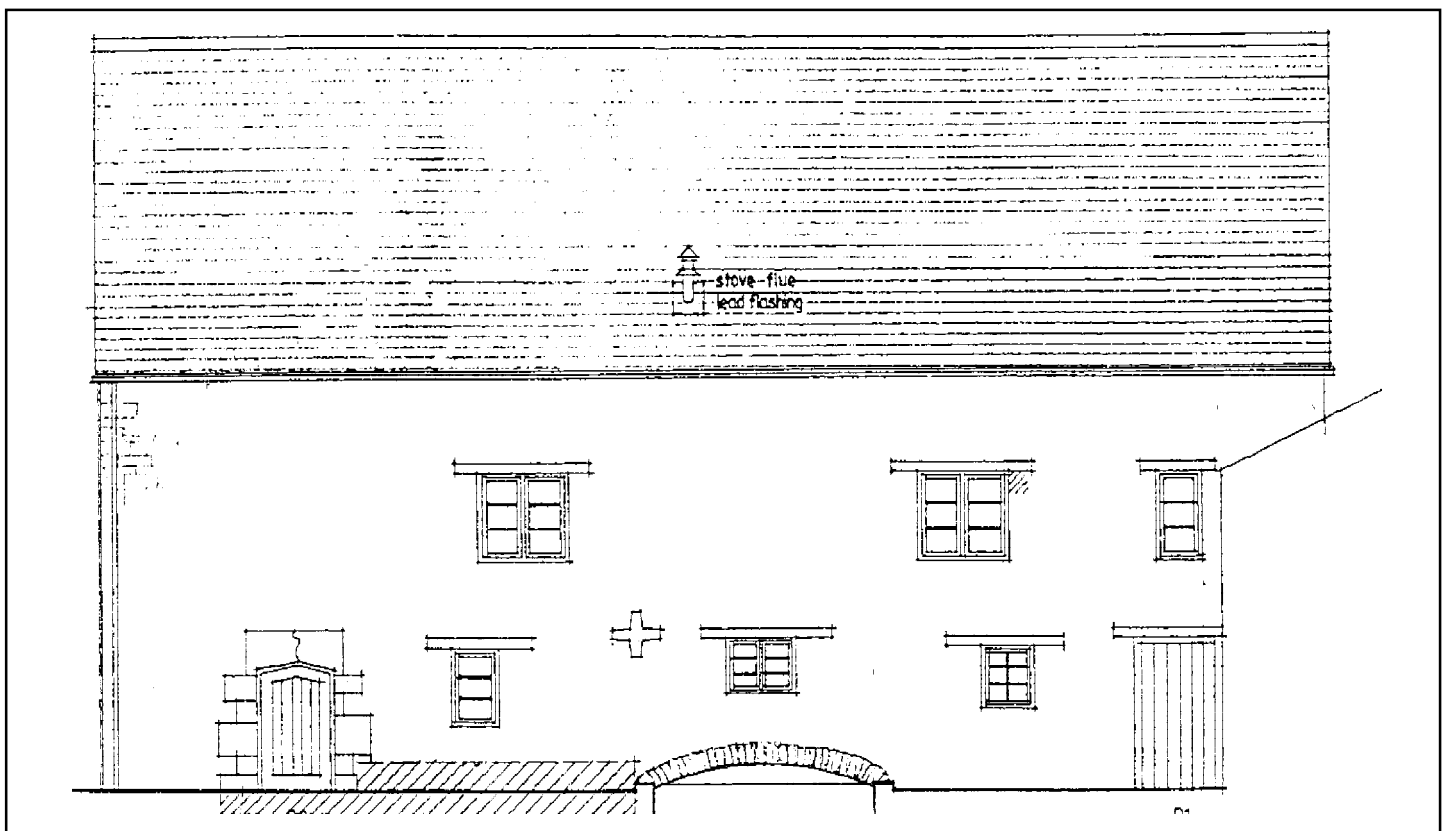
Front and rear elevations of Clifton Mill, Oxfordshire.
