# LAUREL HOUSE, DEDDINGTON, OX15 0TT

## HERITAGE STATEMENT

DECEMBER 2021

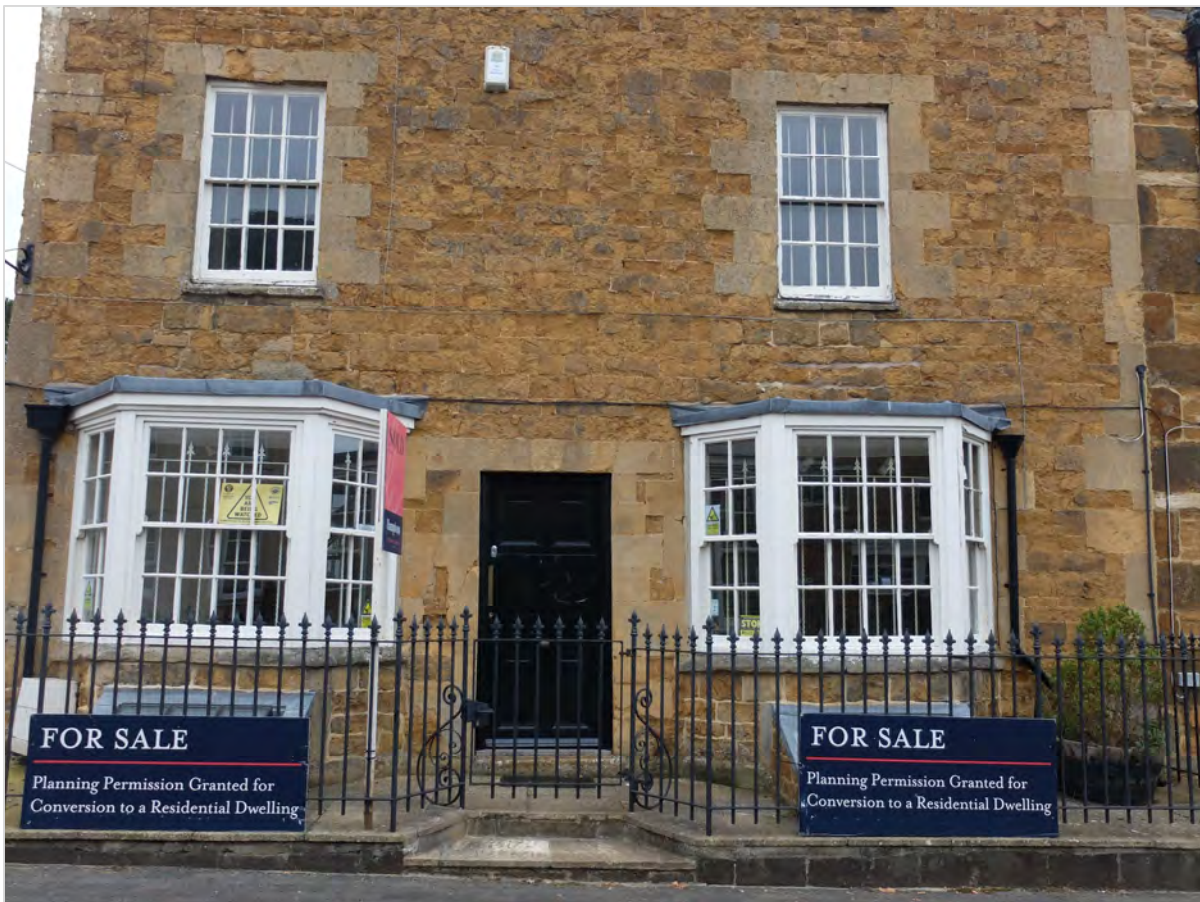
Fig.1

The first phase, from the early 18<sup>th</sup> century, comprised a two storey cottage built of local golden-coloured ironstone or Marlstone, which was the primary walling material in the region for all domestic buildings from the 16<sup>th</sup> century (fig.1). The stone is laid in regular but uneven courses with fine joints almost attaining the character of ashlar work. The window, door dressings and quoins are in an oolitic grey limestone available at the same quarry as the Marlstone. There are several occasions of this use of contrasting stone within Deddington. The mortar for jointing is thought to be an earth mortar.

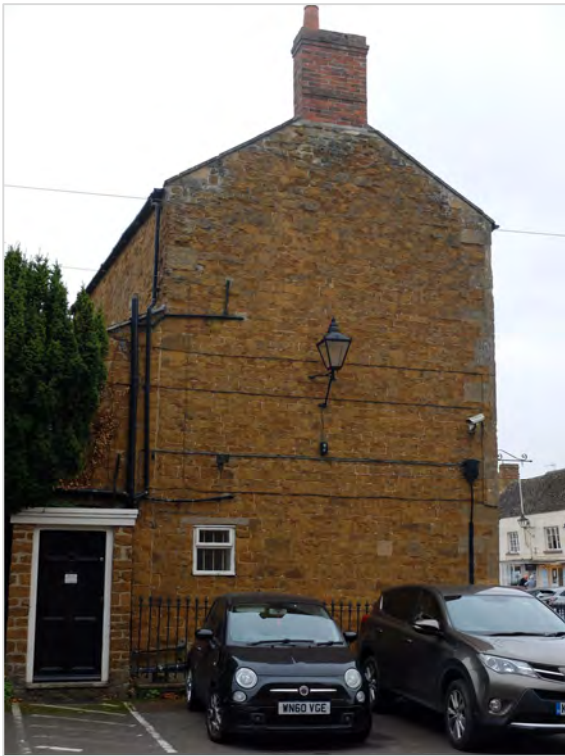
Fig. 2

The structural system and dominant regional plan form of this building typology remained unchanged for over a century making precise dating of the primary site difficult. The quality of the stonework with better dressed and squared stone and the finer joints supports an early 18<sup>th</sup> century date as does some of the remaining features internally. Laurel House conforms with the vernacular tradition and plan form of the building in this early phase. Subsequent phases of development and alteration are, as a rough guide, thought to include a late 18<sup>th</sup> – early 19<sup>th</sup> century phase when the first extension was added. Joinery surrounding fixtures in G2 are consistent with this date. The staircase was probably moved in a later phase and then altered again. Rebuilding occurs for many reasons but a common cause was as a result of a fire. It is unusual that a rebuild would take on such a different form, the brick extensions are notably compact and the actual space gain to the house minimal.

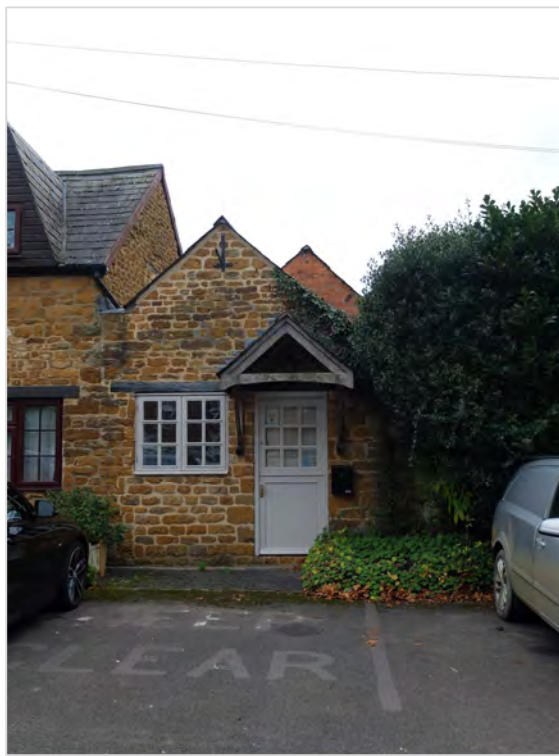
Fig.3

Other regional characteristics are seen in the centrally placed door onto the street front, dominant for most of the 18<sup>th</sup> and early 19<sup>th</sup> century, and the internal arrangement of the ground floor typically subdivided into two principal rooms by a stud partition, with a staircase invariably in the corner of the building and usually by the side of the fireplace. In this case the staircase appears to have been in a separate compartment.

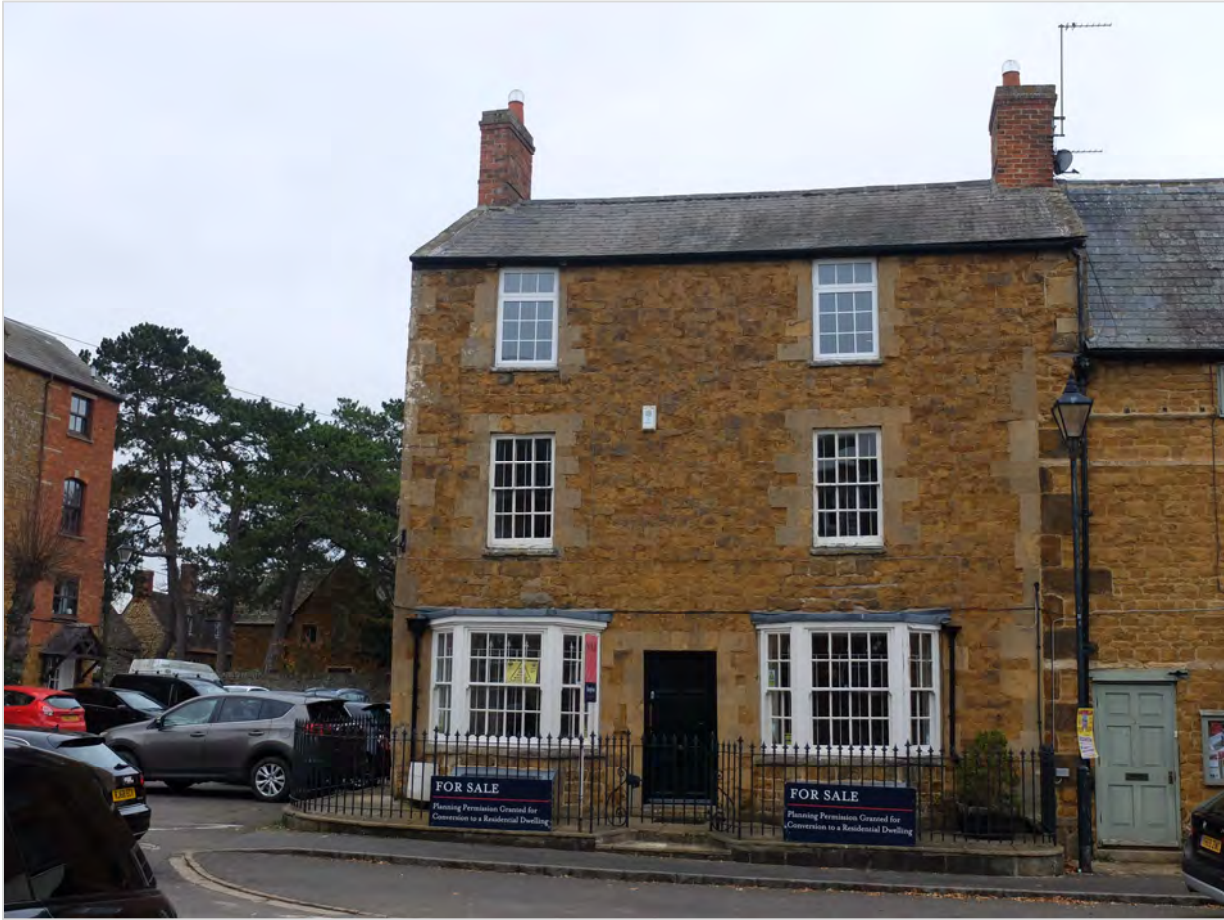
Fig.4

composition, the doors and windows are misaligned. The first and second floor windows are irregularly spaced, with those on the north end closer to the gable end than those on the southern end of the building (fig.4). The top storey of next door is partially concealed within the roofspace creating an attic, while the second floor of 'The Laurels' appears as a full storey from the front. Quoins up to the eaves level of the neighbouring building indicate the previous height of the front, with a curious section of infilled masonry above, almost a flying freehold emphasised by the downpipe of the guttering from Laurel House on the face of the adjoining building (fig.5 & 6). This is not really expressed internally, although the depth of integral cupboards on the party wall do suggest that they extend further back than first indicated.

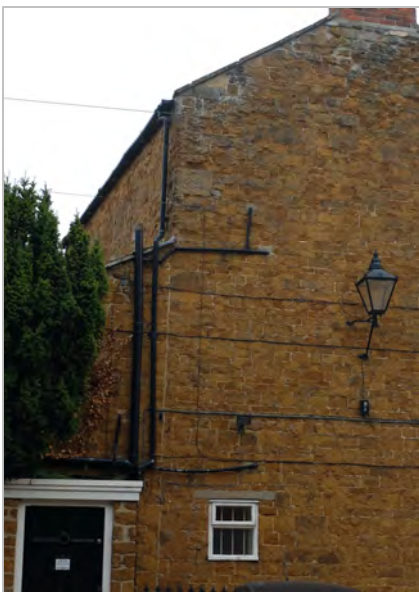
Fig.7

Further evidence of the increase in height is shown on the end gable with differences in the colour, texture and size of the stonework detectable in the quoins and the courses. A straight joint on the east side of the gable shows where the lean to extension was added but less distinct quoins below the intersection of the lean to and the primary building suggest that this section of walling may have been rebuilt (fig.7).

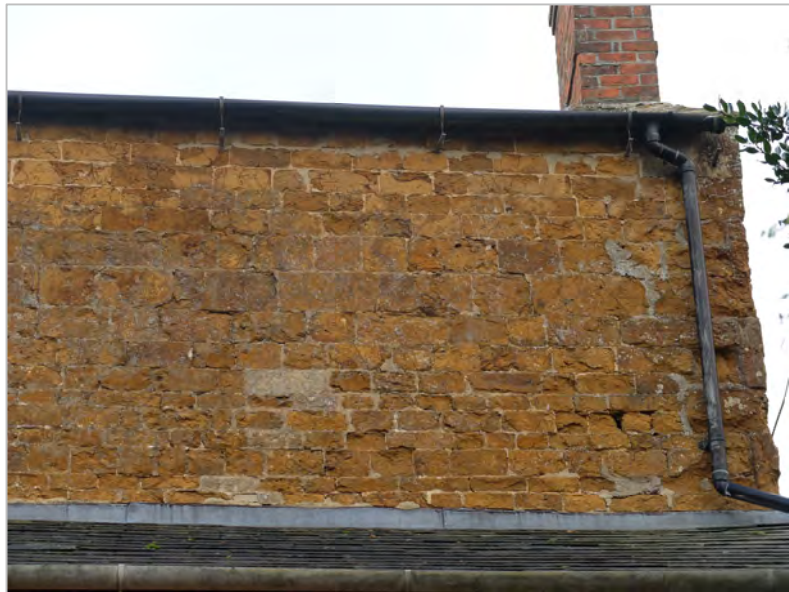
Fig.8

A typical development of the single depth plan was to add an extension to the rear to create a L-shaped plan. In houses below gentry level this was usually to add service or kitchen accommodation rather than extra parlours. This type of extension frequently occurred in the later 18<sup>th</sup>-19<sup>th</sup> century when it was not unusual, as part of the improvements, to alter the windows, or even complete facades. The rear outshot such as seen here with a lean to roof, is unusual in the region and not typical of the type of extension on a building of this class. A faint trace of a gable can be discerned on the rear wall of the host building but its not definitive proof (fig.8). Heavy handed pointing (later work) emphasises the joint between the two ranges but also highlights that they are not structurally integrated.

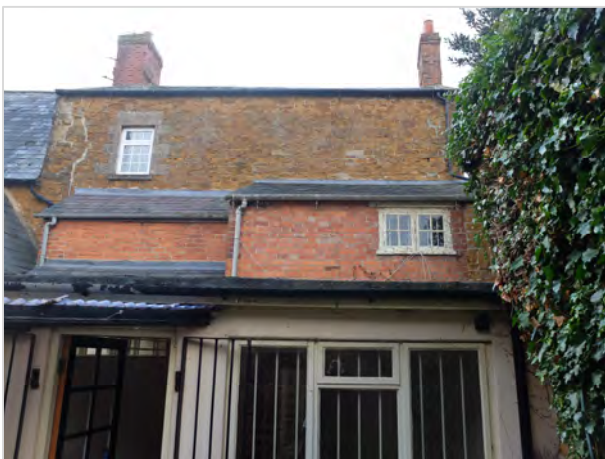
Fig.9

From the rear five distinct phases of development are apparent – the first was raising the height of the building by one storey; the second added a rear wing – which may have been rebuilt; the third added an

extension over the cellar stairs; the fourth over the main stairs; and the fifth added the single storey, rendered extension (fig.9). It is notable that the second floor window is not balanced by a corresponding window on the north side of this elevation which is where the gable would have been. At first floor level the lean to on the northern side (phase 2) is in a Flemish bond neatly abutting the stone side wall (fig.10). The first floor extension on the left (south) built over the higher section of the staircase and the cellar stairs is in a Stretcher bond (phase 3). Below this the further lean to, built over the lower section of the stairs (phase 4) may be coeval but the quality of the brickwork, now painted on the second lower section of wall is of a poorer, irregular quality to the higher section and includes some headers in the bond. The arched window in this wall section is a later addition, infill brickwork below suggests that it was previously a door opening at ground floor level (fig.11). The use of brick is unusual in an area with good stone but this may be connected to the production of brick in the parish from the 19<sup>th</sup> century and its relative cheapness compared to stone in the 20<sup>th</sup> century.

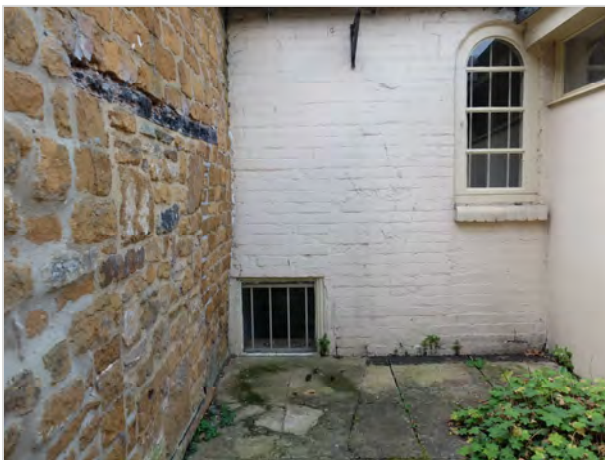
Fig.11

The range to the south of the courtyard was once part of Laurel House (page 34) but is now in the ownership of next door, the walls are built in Marlstone and matches the cruder quality of the front (fig.11). A former passage between the end of the south range and the annex is infilled in two stages with modern brick (fig.13). Historic maps provide evidence of the previous extent of the site which included this range and a section of the adjoining building. Prior to incorporation into next door's curtilage the south range would have been accessed from Laurel House's yard, a wide opening, suitable for animal use is now infilled with matching stone under a decaying timber lintel (fig.14).

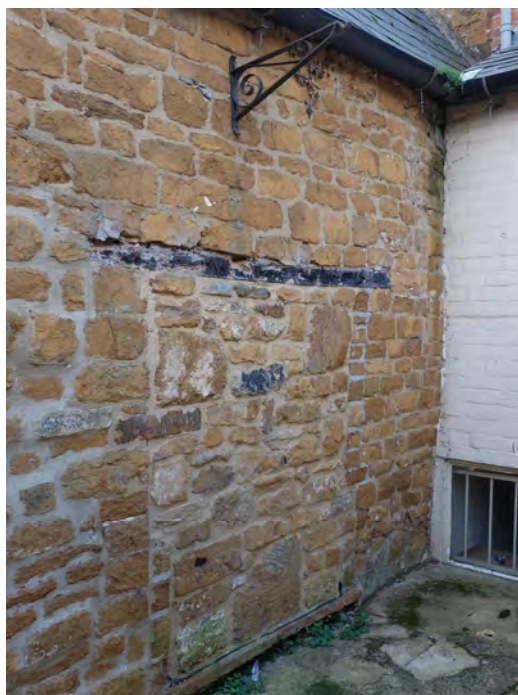
Fig.14

On the left of the rear wall of the main range is a roughly square opening at basement level (fig.14). Internally this presents as a high window on the return of the cellar stairs obscured by two display cabinets

in situ which extend into an alcove to the side of the stairs. It is evident that the ground level in the rear yard has been incrementally raised and given the unusual location of the square window it is suggested that this was an entrance to the cellar accessed from the yard down steps that have either been removed or infilled.

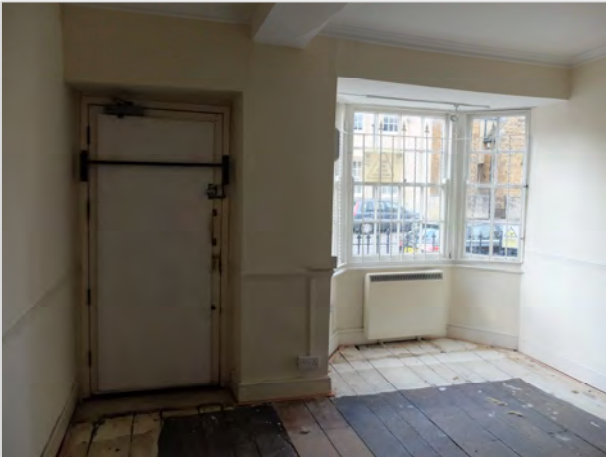
Fig.15

The front door opens straight into the left parlour G1 (fig.15). Immediately on the right is a partition wall, and in line with the front door is a door leading to the first inner lobby area (fig.16). This is within the envelope of the primary building. A plain plastered beam runs from front to back extending through the wall to the WC beyond, resting on the former outer wall of the building. The chimney breast remains in place and there is a deep fire opening, no surround or insert, now lined with fire cement painted grey. Dado rails and skirting have been added, timber panelling below the bay window is absent. Floorboards are partially stained and of irregular widths in Baltic pine, they reach into the bay which suggests that the basic form of the room and the flooring are coeval. The floorboards extend as far as the second lobby area at the rear which supports the view that they are all part of the same phase (fig.17). The first lobby area has an intact plaster cornice on three walls but the fourth, on the section of wall adjacent to the right hand parlour is absent which indicates the location of a passage. A WC is located on the left where the stairs are thought to have been located.

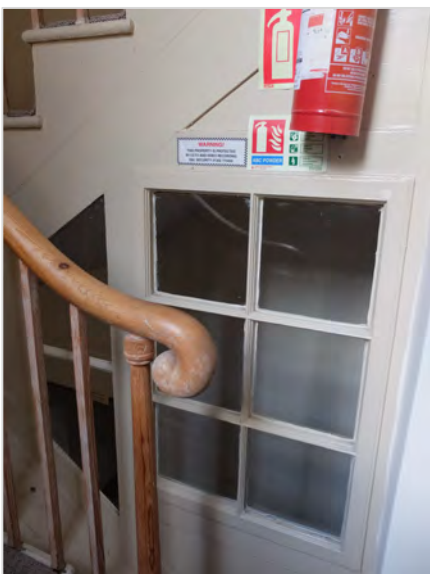
Fig.21

The second lobby provides access to the stairs, the first opening on the right leads down to the basement and to the side of that a comparatively wide, dog leg staircase leads up to the first floor. To the left is the recently added, enclosed porch on the gable end. The floor of the second lobby is laid with polychromatic tessellated tiles below an old vinyl flooring. A modern extension at the rear is accessed from an opening in the far wall of the inner lobby, a step higher than the front range. It projects into the yard, the outer wall has a three light modern top and side hung casement window and the exterior door to the yard is half glazed. To the side inner elevation of the yard there is a row of four, high level, fixed windows. Throughout the ground and first floor all the windows bar this row of fixed windows, and all external doors have modern security bars attached to the frames. The internal door of the porch is a modern reinforced steel door.

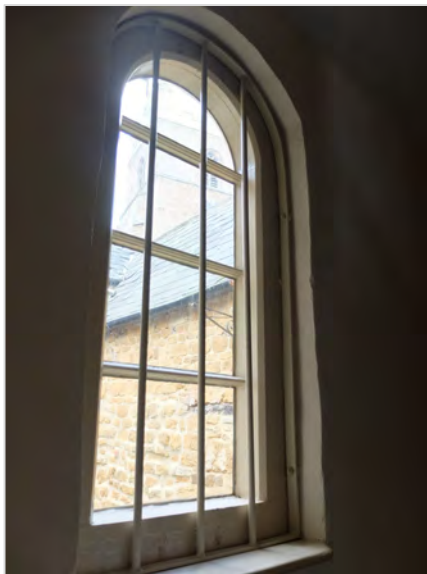
Fig.22

The basement sits under the main range of the building, single unit in depth but spanning the full double width of the house. Well worn stone steps descend in a straight run from the rear lobby area, turning 90° at the base with two steps down to the floor level of the basement. The return on the left of the steps, away from the main cellar, is likely the rear entrance to the yard. Two display cabinets are built into the previous door opening and into a recess to the side under the main stairs. The opening has been blocked as far up as the level of the yard leaving a roughly square opening or overlight at the top. The east, outer wall of the basement stairs is punctured with internal windows that draw light through the building from an arched two light window on the outer wall (fig.21). The frame of the internal window sits proud of the face of the panelling which suggests that it replaced an existing panel. The heavy profile of the joinery here suggest they are fairly modern and of the same phase (fig.22).

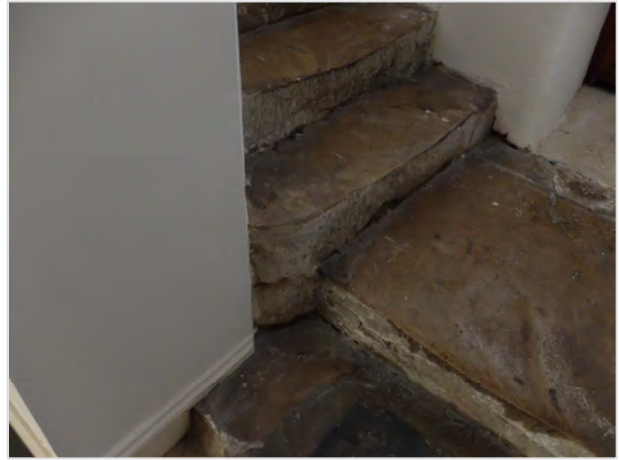
Fig.26

Deeply recessed openings, two to the front and a narrow one to the north allow natural light into the basement, all the wall planes, frames, skirting and windows are modern. The chimney breast on the southern gable shows evidence of different phases of use and adaptation with the main structural form being composed of pale limestone blocks (fig.24). The wide opening of the fireplace consists of a cambered arch of two tiers of brick headers arranged in soldier courses. Bricks now line the opening which presumably housed a kitchen range. Carbon deposits and extreme heat have vitrified the bricks at the rear of the fireplace but the staining is not necessarily historic. The stone steps to the basement are well-worn showing greater age than any other surfaces within the building. At the foot of the stairs a curved step which would normally be at the base is two steps up indicating that the steps have been moved from elsewhere (fig.26).

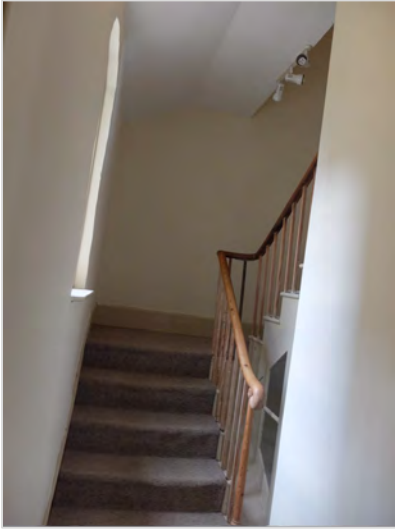
Fig.27

The stairs to the first floor, replacing stairs on the east corner, appear to be relatively modern, possibly reusing elements of an earlier construction (fig.27). They are not of one build phase as can be seen from a section of a different type of wood pieced in at the turn of the stairs supported by an iron stick baluster to stiffen the bannister (fig.28). The graining of the hand rail appears to be a softwood, the stick balusters are pitch pine and the pieced in section a hardwood. The open-string is unadorned and appears to be of a piece with the panelling below. At the top of the stairs there are signs of the stairs having been adapted (fig.29). The junction between the stairs, landing and small rear room (F3) is not fully reconciled. The floor of F3 may have been raised to accommodate services when in use as a bathroom but the discrepancy in floor levels may be further indication of the rear range having been rebuilt. F3 has a two light, two over two casement on the rear wall, and a single light two over two casement on the gable wall. The side wall is clad in modern tongue and groove panelling and modern studwork partially encloses an airing cupboard and emersion heater (fig.30).

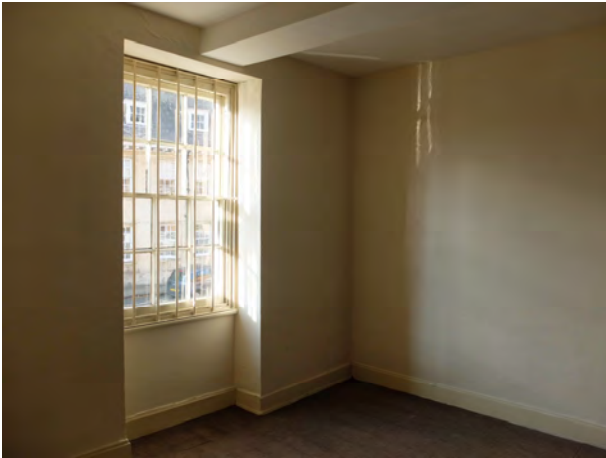
Fig.31

The front range of the building is one step higher than the rear. The right, front bedroom (F2) was probably divided as the ground floor with a passage/landing leading from the original stairs fitting into the recess to the side of the chimney breast. The stairs would have been very narrow but this is not unusual. In the left front room (F1), a door opening on the cross wall, currently infilled with display shelves would have allowed access to a rear range (fig.32). A six over six sash window with lambs tongue glazing bars to the front is set to one side within a deep box reveal and timber surround (fig.31). This, with a matching window in F1 are the oldest two windows in the building stylistically dating from the late 18<sup>th</sup> to early 19<sup>th</sup> century phase. Summer beams in both rooms are boxed in. In F2 a slightly raised hearth is discernible under the carpet but the chimney breast is false. A cupboard is fitted into the under stairs area and a small, integral cupboard, much altered, sits within a wall recess to one side of the chimney, again the cupboard is deeper than it first appears (fig.33).

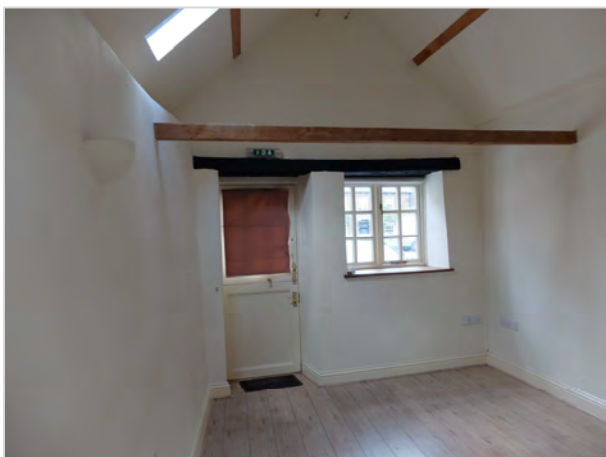
Fig.37

Positioned roughly parallel to the main house, the Annex is accessed from the yard and from a modern porch added to the side elevation opening on to The Bullring. It previously served as an outbuilding, and was converted for use as a garage in the 1950s and its garage doors replaced by the window, door and porch arrangement used as an ancillary room to the main house. Internally most of the fixtures and finishes are modern, however dark stained/painted timbers that once performed a structural function have been retained to maintain the character of the building. Modern studwork encloses a toilet with storage cupboards above. Attached to the partition is a small wash basin. The external walls are deep which has been consistently applied to the infill wall to the street side elevation where the garage doors were once sited. The floor is suspended, presumably over a cement screed, and all the joinery is modern. A reclaimed four panel pine door has been fitted to the modern partition but otherwise the stable door to the side entrance and the plank door to the yard are both modern. Two small rooflights are on the south slope of the roof between the rafters of the exposed roof truss which is modern, the underside is boxed in with plasterboard.

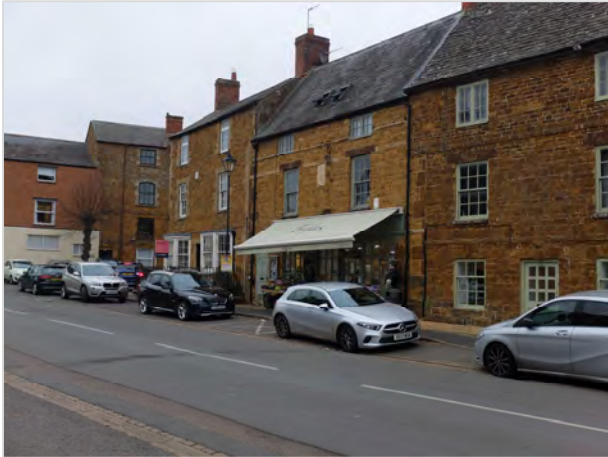
Fig.39

The Conservation Area is divided into several character zones. Laurel House is within the Market Place zone. The street layout of the settlement forms a loose grid which in combination with a continuous building line forms a strong sense of enclosure. That said The Bullring is an unusual configuration with outward facing buildings clustered together on a central island. This is flanked to the north by a row of cottages and houses, to the east by Castle House and grounds, to the west by a main route into Deddington from Hempton, and to the south by the side elevation of Laurel House, boundary wall, annex

and adjoining cottage (fig.39). The Bullring and Market Place, historically the centre of commercial activity has retained its semi-urban character.

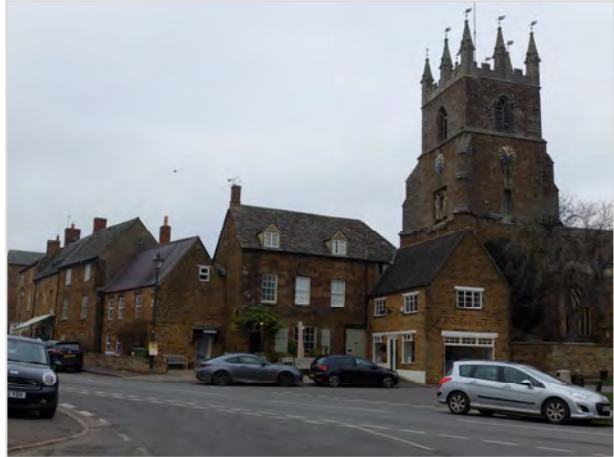
Fig.40

The church is set back behind Laurel House and the adjoining row of shops and cottages that front on to Market Place (fig.40). From the upper storeys of Laurel House close views of the church are possible. Viewed from the Bullring the church could appear overbearing and in danger of overwhelming the domestic scale of Market Place. However it is separated by a back lane that is sufficient to prevent this from occurring. The result is a close grained, intimate setting, visually harmonious due to the prevalent use of Marlstone.

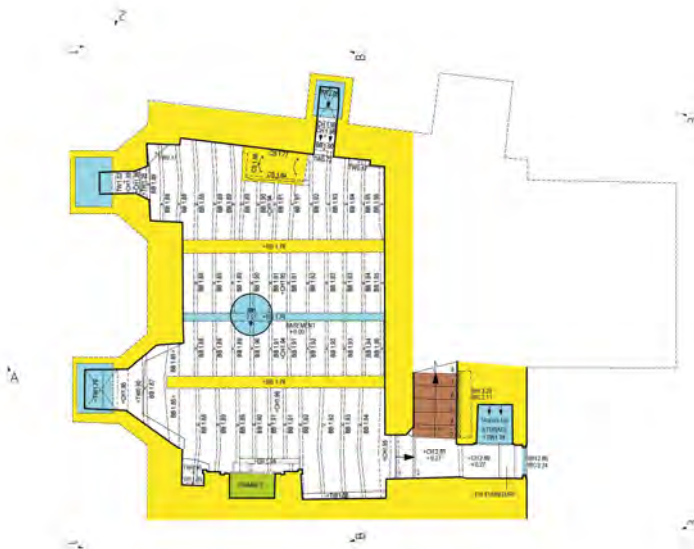
Basement plan

18th Century
  19th Century
  19th/20th C
  20th Century

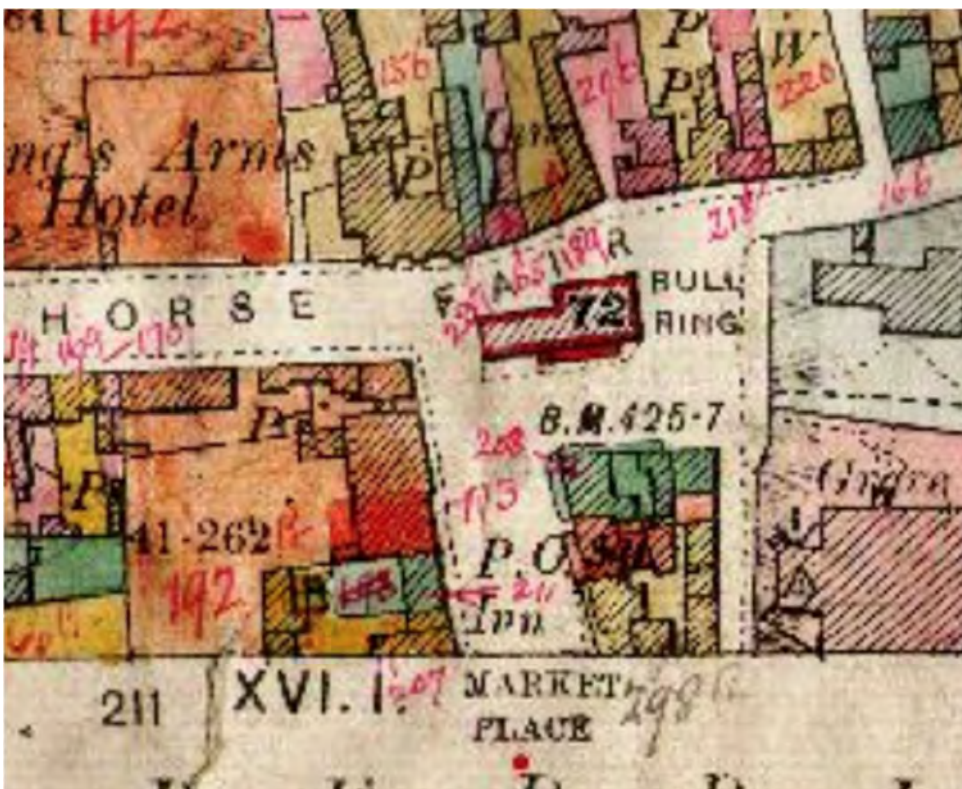
District Valuer Map 1910 Laurel House is number 208 in the Survey Record Books – entire block shown in green and therefore in the same ownership.

Cartographic sources from the late 19<sup>th</sup> century show the historic layout of the site with the rear range within the curtilage of Laurel House and the Annex a single, uninterrupted range that extends into the rear yard of the adjoining building. A small gap is shown between the rear range and the Annex in the later maps but there appears to be a small building set back from the building line in the 1881 OS map. The maps appear to show that a significant part of the original house is now part of the curtilage of the adjoining building. The 1910 District Valuation map shows the extent of ownership which included the

entire Annex range and a further attached range to its side. Visual assessment of this area shows significant rebuilding in brick but with some of the original stone walls in place.
