HERITAGE STATEMENT

CROWN AND TUNS NEW STREET DEDDINGTON OX15 0SP

Prepared for Josh Cowdery and Stephanie Aspin, Crown and Tuns, Deddington, OX15 0SP.
By Wendy Tomlinson MSc, PG Cert (OXON), IHBC.

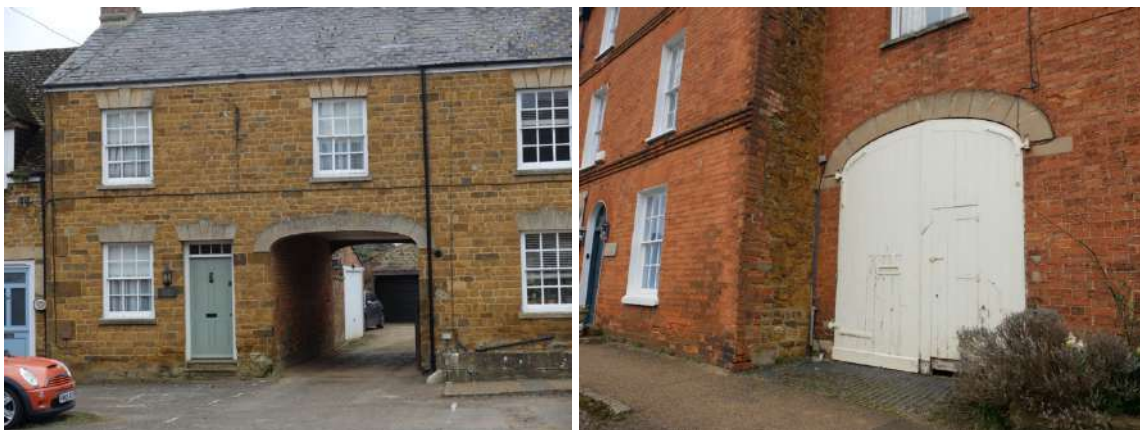
Fig.3 - 4 Carriage and cart entrances New Street

The Crown and Tuns likely originated as a farmhouse, a detached house with a cart entrance to one side. Houses within farming communities like Deddington grew up within villages, along the village street. Sites were long and narrow, and houses were invariably parallel to the street and would usually extend across the whole width of a site apart from a cartway at one end providing access from the street to the yard. Behind the house lay the farmyard flanked by farm buildings. The strip of land would be laid out for planting with an area arranged as an orchard. Those on the east side of New Street may have extended to the open fields which surrounded the village until enclosure. Village streets changed their appearance late 18th century with the building of cottage terraces infilling between earlier detached dwellings. Likely, the cart entrance which is such a dominant feature of the building was added when infill development to either side occurred. Many of the cottages and houses in Deddington have retained their cart entrances, some with courtyards and re-purposed workshops at the rear.

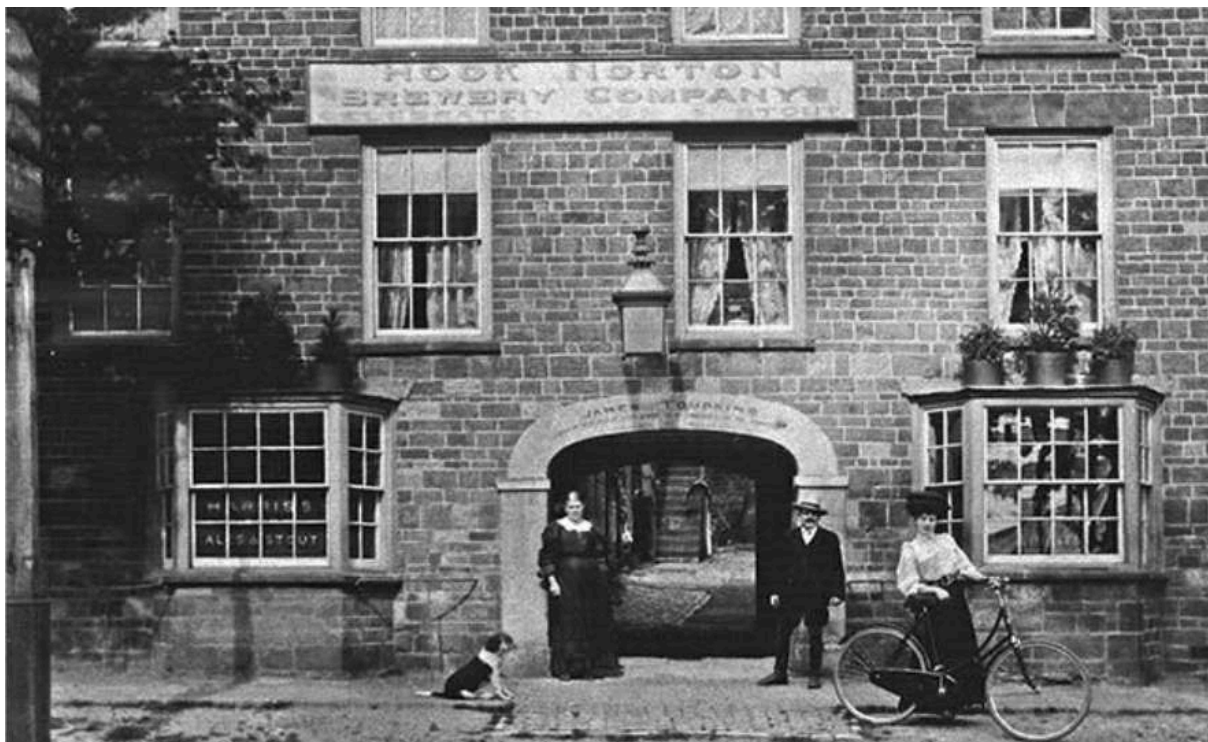
Fig.11 The Crown and Tuns 1900s [<https://www.deddington.org.uk/gallery>]

A photograph likely dating from the early 1900s appears to show members of the Tompkins family outside the Crown and Tuns [Fig.11]. A prominent Hook Norton Brewery sign is suspended between the two central first-floor windows, drawing attention to the slightly asymmetrical placement of the carriage entrance below. The absence of visible voussoirs suggests that the stonework may have been rendered or painted at the time, with licensing details applied across the flattened arch leading to the rear yard, where an external staircase is visible.

Surface treatments within the yard appear to vary, with discernible changes in floor texture suggesting a mix of flagstones or compacted earth, and cobbles. The uneven surface to the left of the passage, possibly cobbled in the photograph, is now surfaced with modern riven stone paving, distinct from the smoother flags adjacent to it. Reference to cobbles in the rear yard appears in a 2012 planning application, in which the applicant notes their presence and proposes their retention beneath the timber decking proposed. A hanging pub sign mounted on a post is faintly visible on the left side of the image, resembling the position shown on Joseph Wilkins' 1860 map [Fig.20] and today's post. The lantern above the carriage entrance also appears consistent with the one still in place today.

On the earliest map, surveyed in 1880 and published in 1881, the main range of the building is continuous with adjoining structures, set hard to the pavement, and backed by ancillary ranges or outbuildings arranged around a courtyard or yard space, by now characteristic of a coaching inn layout. The footprint of the building is shown as a series of separate units in a linear arrangement on either side of the plot with an open passage and yard behind shown as three compartments or perhaps levels, the furthest a planted area or orchard. The two rear wings of similar length extend across nearly half the length of the plot. It seems likely that the sub-divisions shown are indications of different uses as well as separate units which suggests that the southern range comprised a long outbuilding, probably a stable, and the northern range was accommodation. Attached to the northern wing is a small bay or external staircase [see Fig.11].

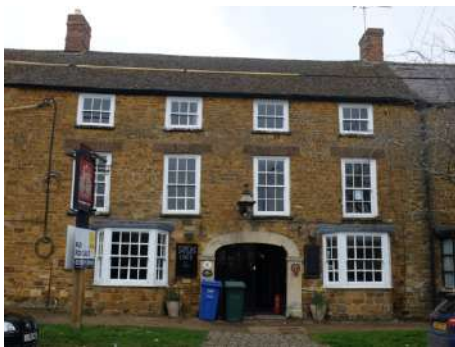
Fig.28 Crown and Tuns front elevation

At ground level, the building is distinguished by a limestone carriage arch, articulated with dressed voussoirs and a keystone, providing a clear axial passage through the depth of the building. The arch is notably offset from the principal centreline, and its ashlar face, now almost flush with the surrounding rubblestone masonry, contrasts subtly with the recessed pilasters adjacent—an irregularity that may owe itself to over-cleaning or the partial loss of the original surface texture. Such evidence suggests the arch is likely a later insertion.

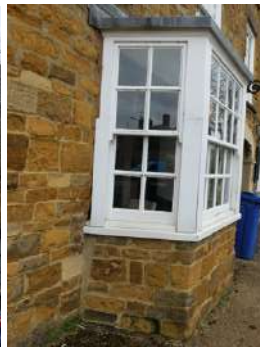
Fig.29 Front bay c.1950

Flanking the arch are two, canted bay windows—timber-framed and set upon stone plinths, likely late 19th-century in origin and subsequently replaced in the mid-20th century. To one side of the left-hand bay are two oval stone plaques with moulded surrounds, they may have served a commemorative or decorative purpose to advertise the brewery or other affiliations. However, similar oeil-de-beauf windows have been found predominantly 1660s to 1720s with peak use in the 1690s [L. Hall Period House Fixtures and Fittings, P.75Fig.3.22]. Though similar in form, each bears distinct characteristics in detailing and finish, indicating they were inserted at different times. Traditional pub signage, bracketed lanterns, and hanging signs, now redundant, remain in situ.

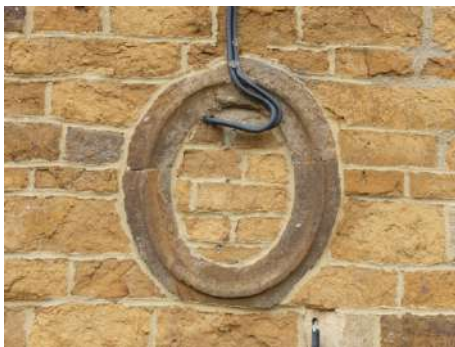
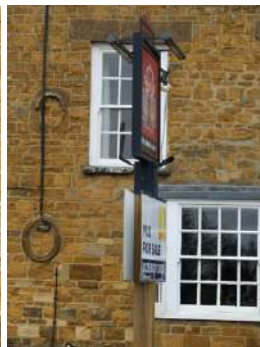
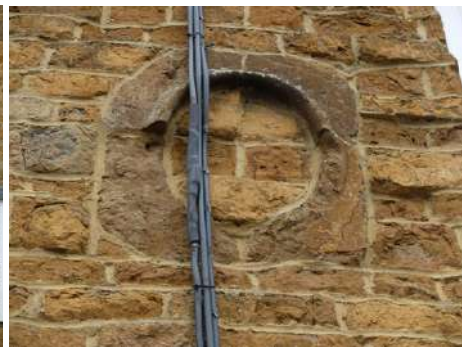
Figs.31 - 33 Decorative oval plaques harmed by badly positioned cabling- later infill particularly noticeable on the lower of the two.

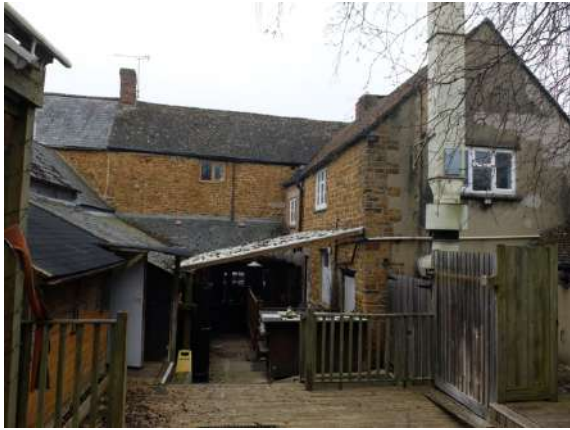
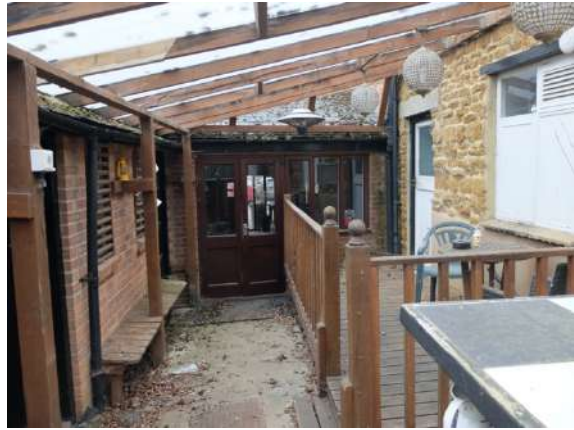
Fig.34 - 35 Rear elevation littered with temporary shelters, fencing, raised decking and covered areas.

Across the rear, a lean-to extension was added providing covered access to the toilets via a small lobby. The toilets were inserted into former outbuildings along with several storage areas with modern brick and blockwork partitions accessed from the yard. Remnants of past outbuildings have been retained in the yard, in some cases incorporated into later timber structures, most are illegible due to neglect or obscured by modern structures.

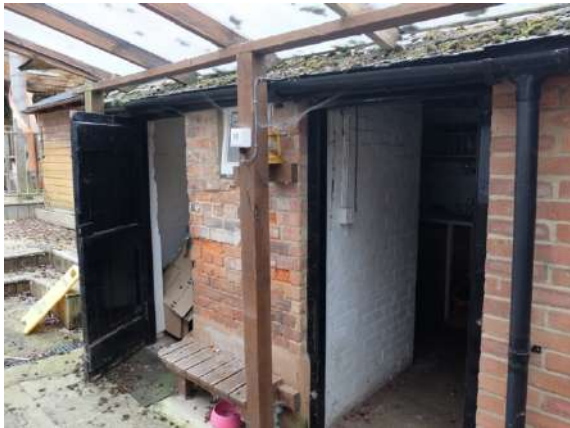
Fig.36- 37 Former stable range used for storage - brickwork showing several phases of construction.

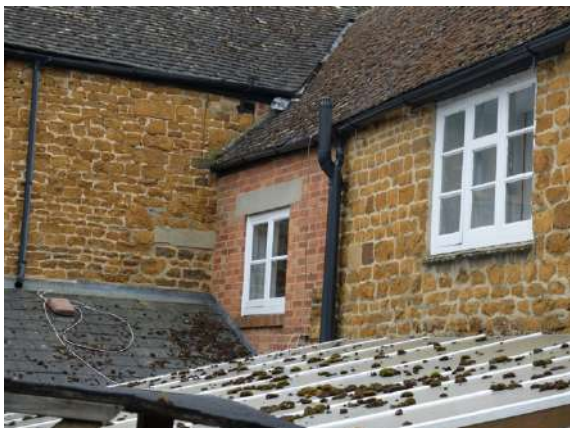
Fig.38 Infill brickwork and disturbed stonework and lintel Fig.39 End gable rendered with large extraction flue

Additional harm is evident in replacement windows of inconsistent material and style and in wall sections showing infilled or altered openings using modern brick. Notably, evidence of earlier structural elements—such as the potential remains of a gallery or former staircase access—survive in the stone and brick fabric but are now difficult to interpret due to piecemeal interventions. A covered service corridor with a timber roof and screening, while functional, further obscures the rear layout and contributes to a sense of visual clutter.

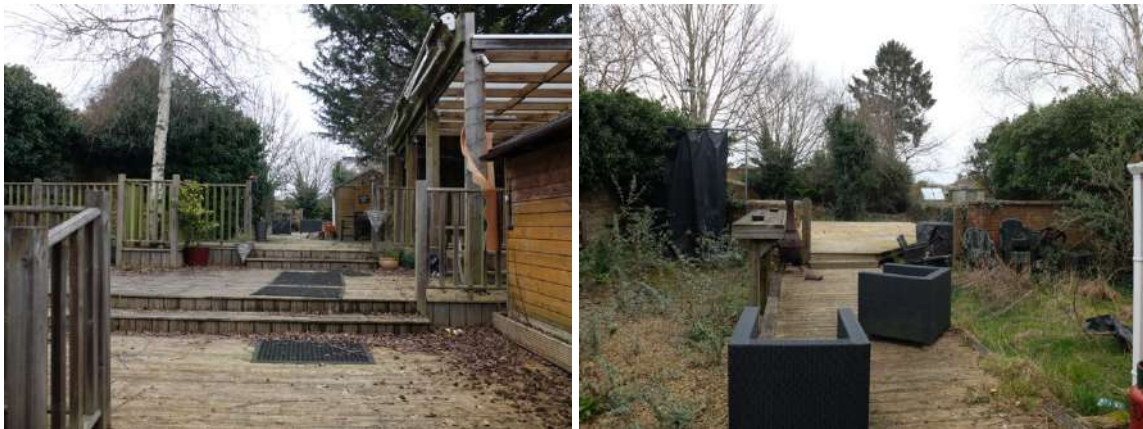
Fig.40 - 41 Decked platforms follow the sloped topography of the site intercut by stone or brick walls.

overall is in a deteriorating condition, with signs of neglect evident in the encroaching vegetation and weathering of materials. While the garden does contain some planting, much of it is now overgrown, and features such as a small pond and remnant fruit trees are obscured.

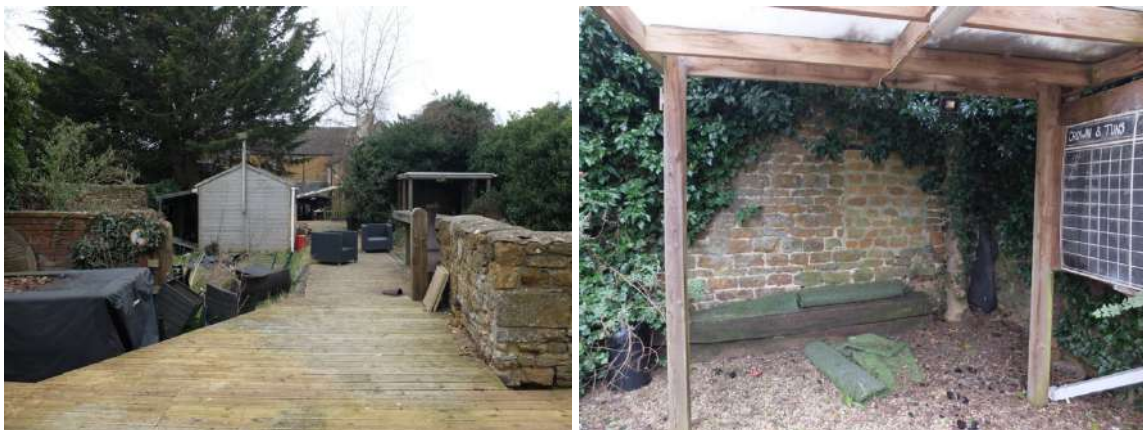
Fig.42 Expanses of decking wrap around stone and brick walls. Fig. 43 Infilled void in an older structure, rear yard.

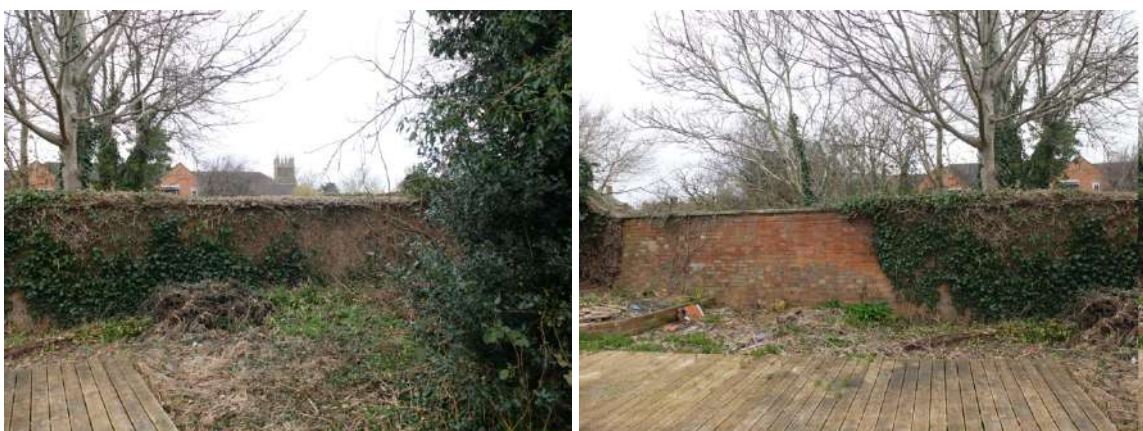
To the north, partial views open towards the parish church tower and to the south, views extend across neighbouring garden plots. This is possible at the far end of the garden due to the rising topography and because the boundary walls are kept comparatively low.

Fig.44-45 Views north towards the parish church and south across neighbouring gardens. Boundary walls in a mix of stone and brick.

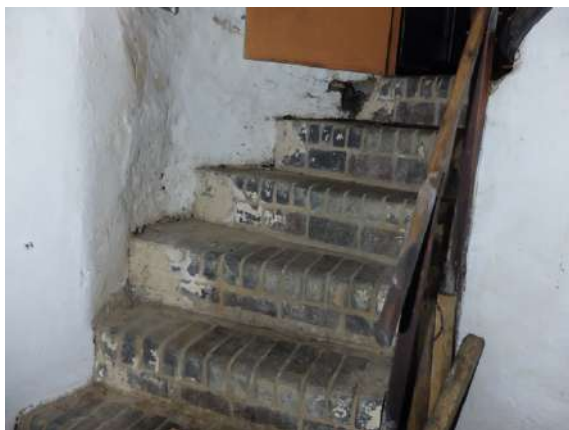
Fig.47 Cellar steps from the main bar area.

The site slopes upward from front to rear, with multiple level changes managed through short flights of steps that contribute to the building's rambling character. The partial loss of a principal staircase has compromised both the spatial coherence and historic legibility of the internal plan. The cellar, located primarily beneath the northern rear range, is accessed via a set of shallow engineering-brick steps to the rear of the bar. Its positioning and construction suggest it is a secondary addition, likely introduced following the building's conversion to an inn.

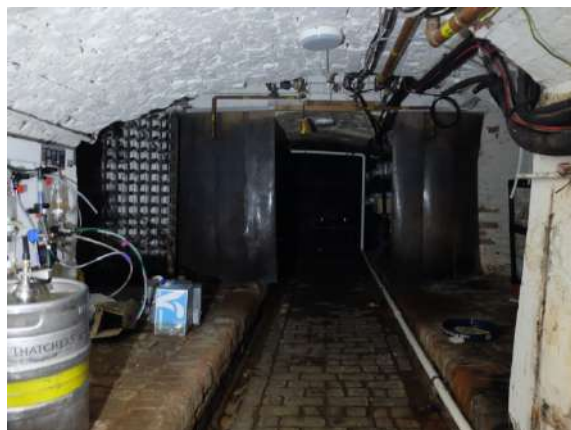
Fig.48 Brick-lined cellar with drainage channels and plinths

The cellar comprises a linear, barrel-vaulted, brick-lined space with a stone and brick floor, incorporating drainage channels and raised plinths on either side for barrel storage. Additional features include two curved recesses on each side and a barrel run on the right-hand side aligned with an opening to the yard. The far end of the cellar is partially obstructed by modern blockwork, beyond which a further chamber extends beneath the rear yard.

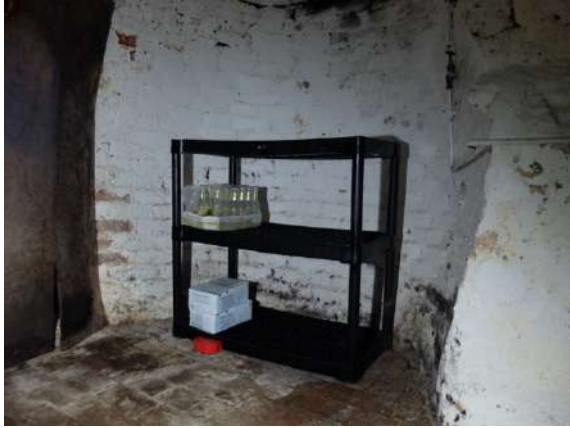
Fig.49 Curved recess RHS matches similar opposite

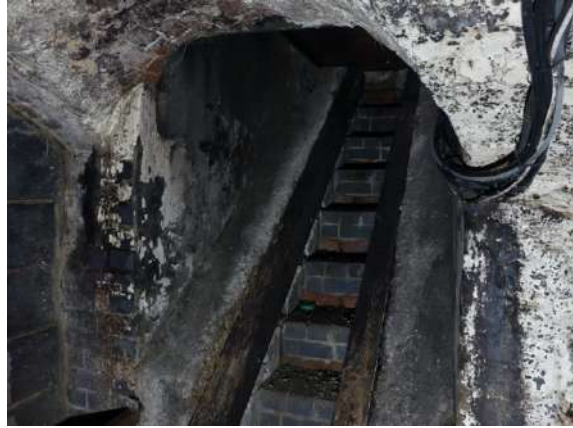
Fig.50 Barrel-run from the rear yard

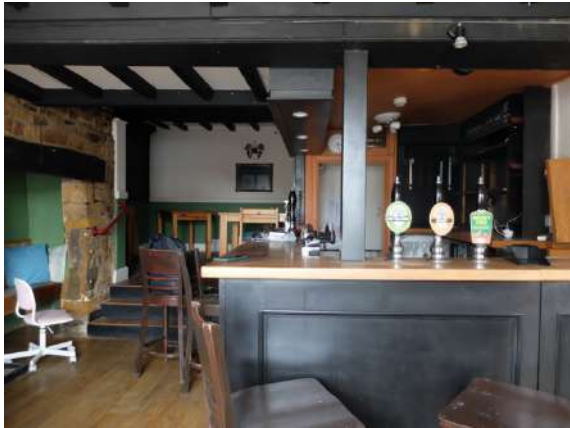
Fig.51 G1 Main bar area

Though the space has undergone notable alteration, aspects of historic significance remain legible despite partial obscuration by later commercial adaptations.

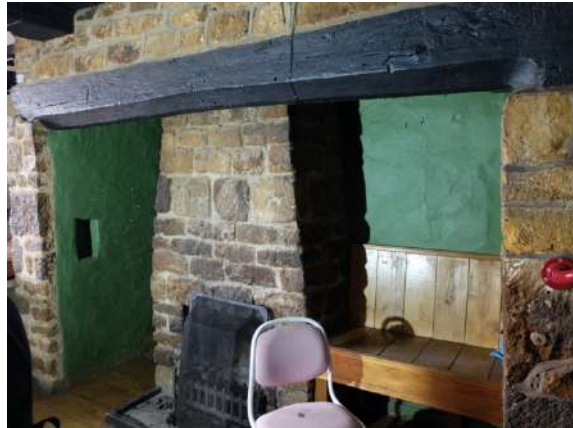
Fig.52 'Iglenook' with inserted chimney breast and fire grate

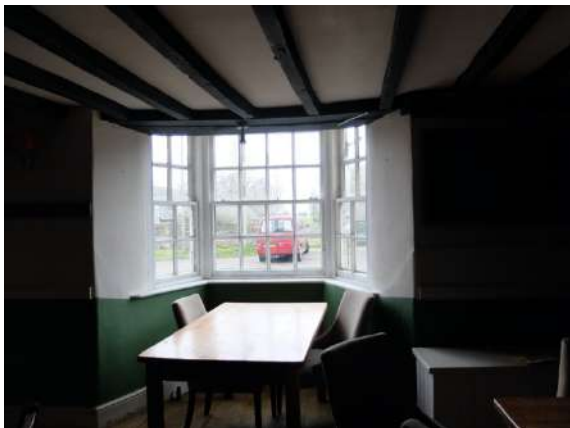
Fig.53 Front bay window

The bay window to the front of the building remains a key architectural feature retaining its traditional multi-pane sash structure, set within a deep reveal that shows the thickness of the stone wall construction.

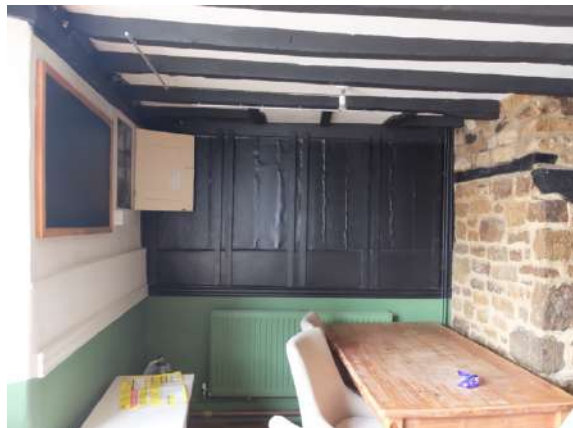
Fig.54 Note trimmed ceiling joists, small cupboard to front

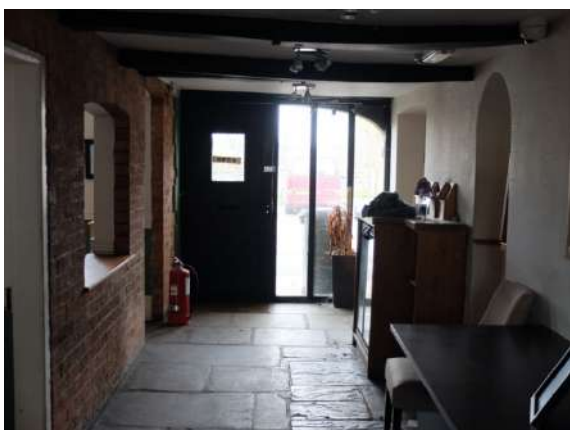
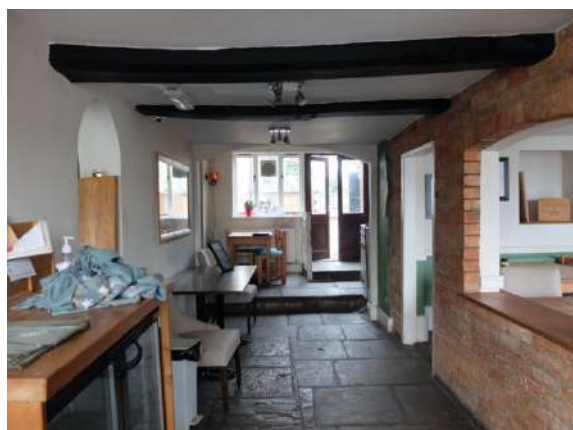
Fig.55 - 56 G2 Carriage entrance, flagged floor and 'cobbled area' to one side. Door and glazed screen to front and half-glazed doors and window to rear yard. Reinforced cross beams, and exposed brickwork with a mix of contrived and re-purposed openings lining the passage.

G2: Central passage - originally the cart entrance, remains a legible and distinctive element within the building defined by its linear form. Flooring consists of large, irregular flagstones, likely of local stone, with an infill section using a deeply riven stone corresponding with a cobbled area visible in old photographs of the building [Fig.9]. The interior wall treatment includes exposed brickwork and areas of historic marlstone, interspersed with modern plastered surfaces. The ceiling beams spanning the passage have been strengthened with embedded metal plates bolted to the underside of the beam, which is plain chamfered continuing to the walls on each side.

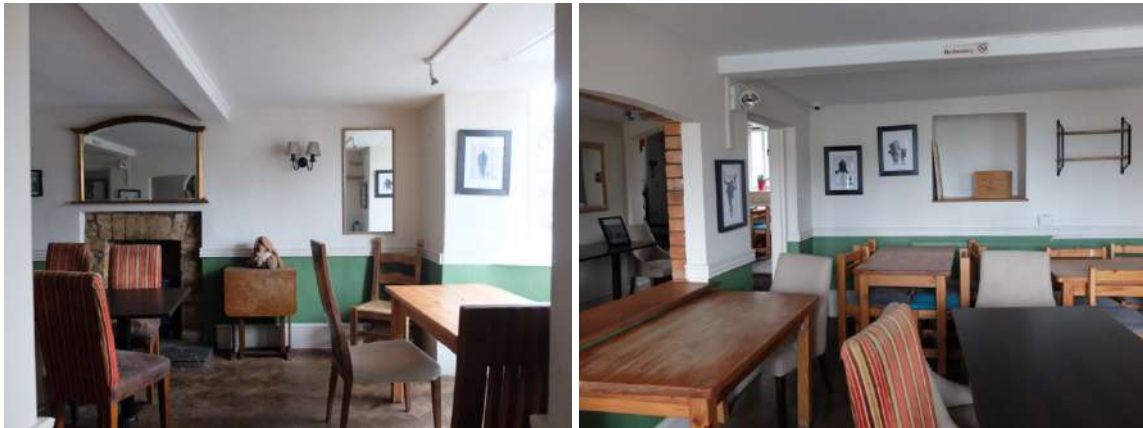
Figs.57 -58 G3 'Dining area' with parquet floor and blocked window opening at the rear.

G3: 'Dining area' - internal finishes within the right-hand bar area are predominantly contemporary, consisting of painted plaster walls with a contrasting dado rail, timber skirting, and painted ceiling beams. These elements provide limited evidence of traditional character. A notable surviving historic feature is the exposed marlstone fireplace with a stone lintel, which, despite subsequent infill and adaptation to accommodate an electric stove, is likely of early construction but would not have been exposed as today. Herringbone parquet flooring appears to be a later addition, possibly associated with a mid-to late-20th-century refurbishment. Architectural features such as the recess in the rear wall and wall openings along the adjoining passage suggest former spatial arrangements and functions but may not be a wholly accurate representation of openings.

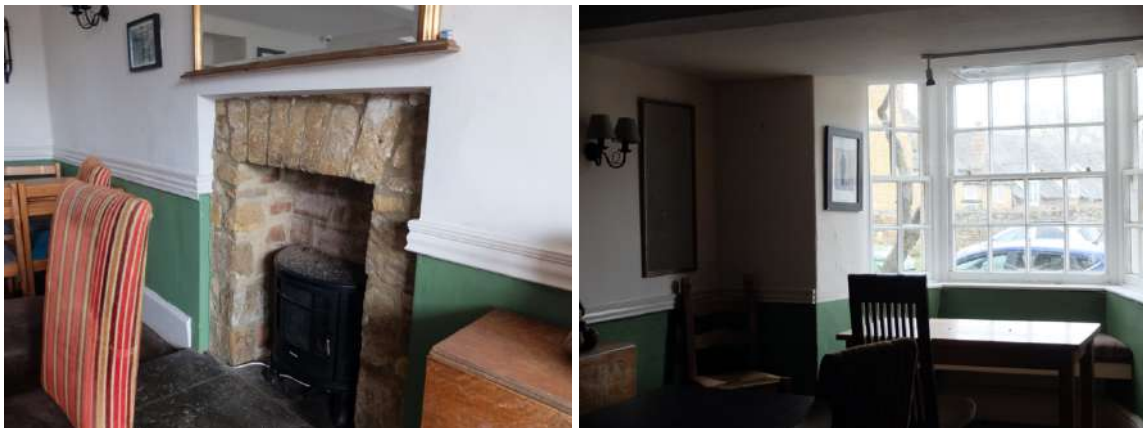
Figs.59 - 60 G3 Stone fire surround and returns, with stone soldier course lintel, brick infill at rear and modern wood burner. Boxed in cross beams, possible steels and matching bay at the front.

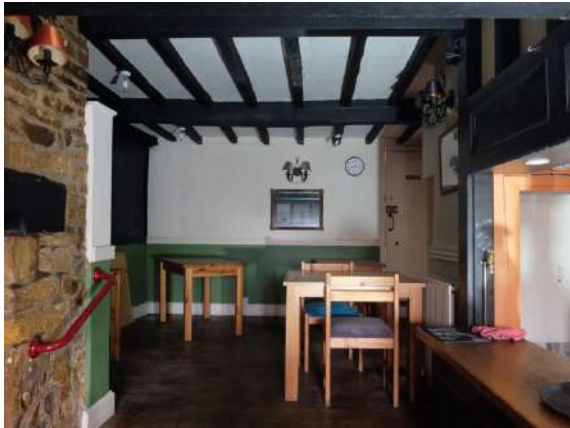
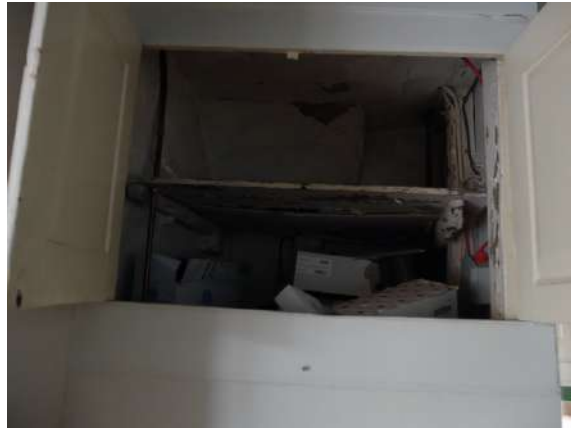
Fig.61-62 G4 Raised bar area at the rear of G1. Retained section of wall RHS and cupboard in the rear with a section of the underside of C19 stairs at the back of the cupboard.

G4: Rear bar area - contiguous with G1 Main Bar - modest, enclosed space delineated by a shallow change in level from the main bar area. The split-level layout reveals some of the original floor plan divisions. The space features a low ceiling with exposed painted timber beams. Wall finishes are consistent with the rest of the interior, comprising painted plaster above a green dado rail, with timber skirting below. The floor is finished with engineered timber planks, and the joinery elements throughout the space are utilitarian and of recent construction. The layout and spatial arrangement imply that this area may have originally served a service or ancillary function, subsequently adapted for customer use. A substantial pillar separates the bar from the rear section, incorporating a wall-mounted cupboard facing the rear of the building. Within this cupboard is a surviving fragment of an earlier staircase that once connected the ground and first floors C19. A doorway at the rear leads to the kitchen /service area (G7). Overall, the rear of the left-hand bar retains limited heritage fabric but contributes to the overall understanding of the building's plan form and its successive adaptations over time.

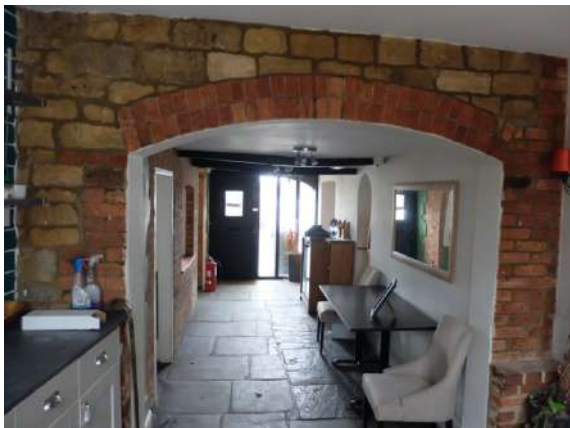
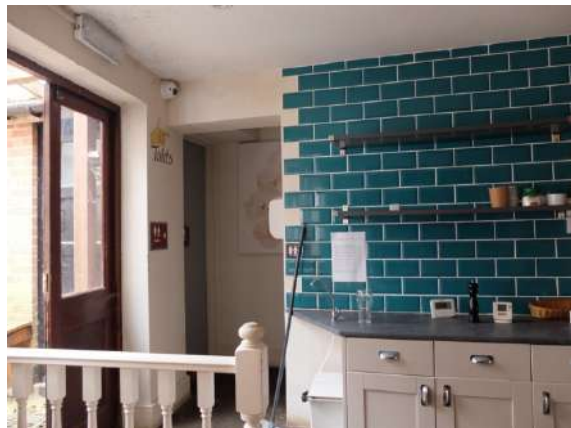
G5: Comprises a lean-to structure attached to G2 that spans G4 - G6 providing covered access to the rear south range, currently arranged as lobby with access to male and female toilets. The rear is now enclosed by a glazed rear door and side window but a red brick arch set into marlstone marks the threshold between the front and rear halves of the passage and the extent of the historic building.

Fig.63 - 64 G5 Brick and stone 'external' wall of the main range. Lobby entrance to WCs and rear southern range (stables)

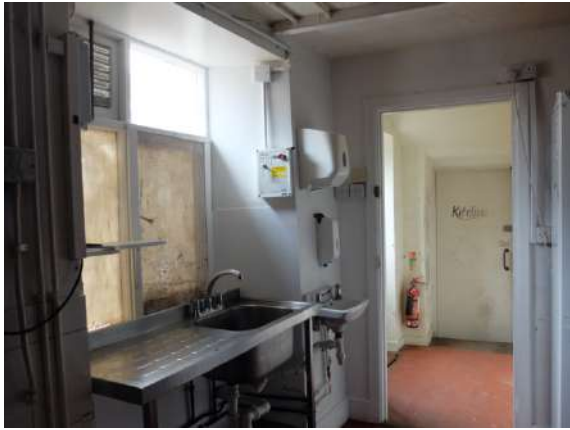
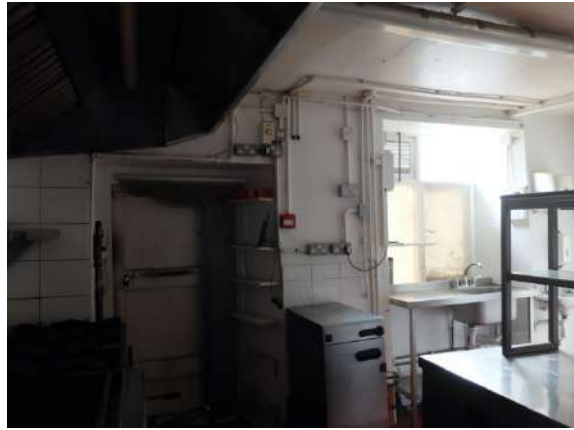
Fig.65 - 66 G7 Partially blocked windows and doors within deep recesses on south-facing side elevation

G7: Commercial kitchen with a range of free-standing and fitted steel cabinets and hoods commensurate with its former use. Blocked windows to the side and plank rear door to yard set into deep recesses. Door to small boiler room single-storey extension on the rear wall. Door to winder staircase to the first floor only (F9). Shelving set into recess with a hole in the floor to the cellar below - joinery detail suggests the shelving is historic.

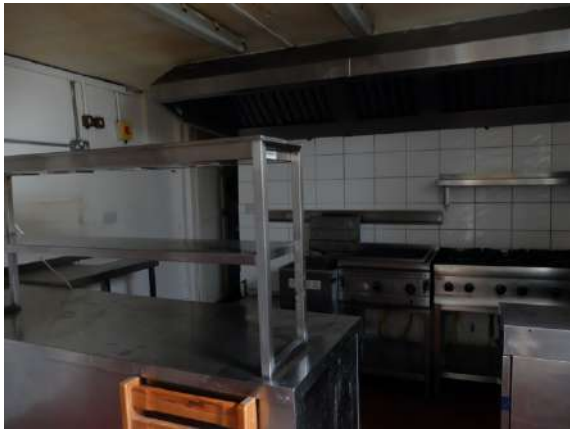
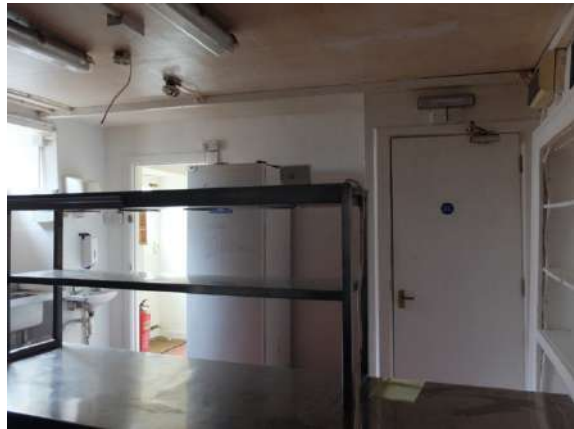
Fig.67 G7 Commercial kitchen units - boiler room LHS corner. Fig.68 G7 Door to F9 stairs to first floor

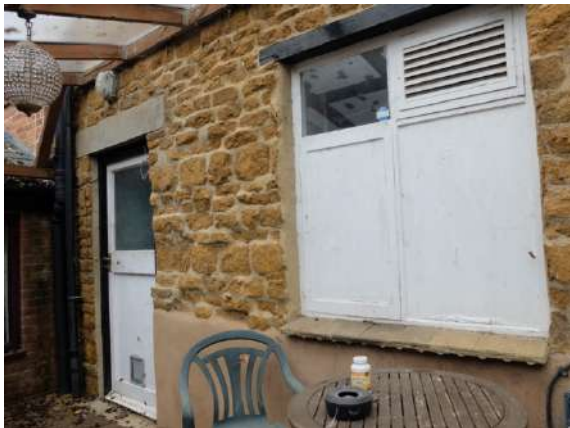
Fig.69 - 70 Side elevation - rendered to sill height, concrete lintel to half-glazed door and timber lintel to plank door. A horseshoe affixed to the lintel may indicate former use as a stable.

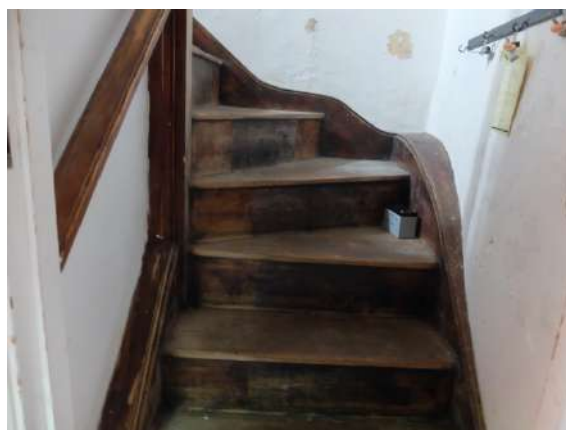
Fig.72 F9 Stained timber stairs plain nosed treads

F9: Enclosed C19 backstairs with wooden treads, winder then straight run from rear kitchen (G7) to first-floor landing (F8). Modern bannister with no balusters. An uneven section of wall at the top of the stairs on the right-hand side suggests the bottom section of the second flight to the second floor, possibly extant now blocked, was exposed at the base - see F8 bottom step visible.

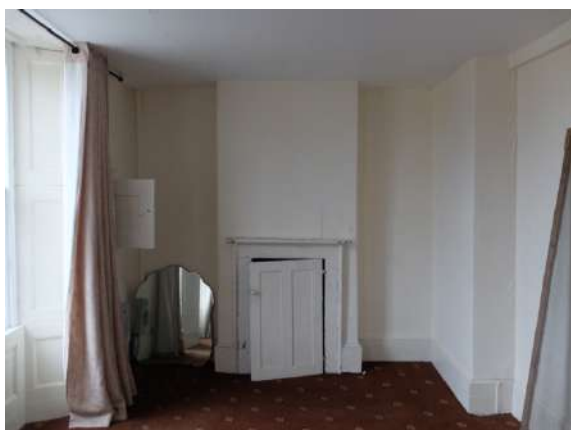
First Floor F1: Reception Room - NW front facing. Retains a few elements reflective of its 18th-century origins, although it has undergone various later modifications. Key features include pair of sash windows, panelled reveals with concealed shutter boxes and shutters (painted over). The chimney breast has been altered, with a small cupboard inserted where a fireplace would have originally been located - brick and stonework fireback in situ, plain timber surround C19. A small cupboard currently housing a safe corresponds with the decorative plaque on the external elevation, its outline is discernible in the plaster finish at the back of the cupboard [Fig.75-76]. The room is divided by timber wall panelling with moulded recessed panels - they may have once folded back but no hinges are evident. Appears to be C20. The cross-wall is largely absent with another section of timber panelling infilled, finished level F1 side with applied moulding and recessed panels F5 side [Fig.74]. The ceiling appears to have been lowered or boarded over suggested by the poor junction between the window panelling and ceiling plane. Plain skirtings and door surrounds, 4-panelled door

Fig.73 F1 Truncated spine wall on RHS

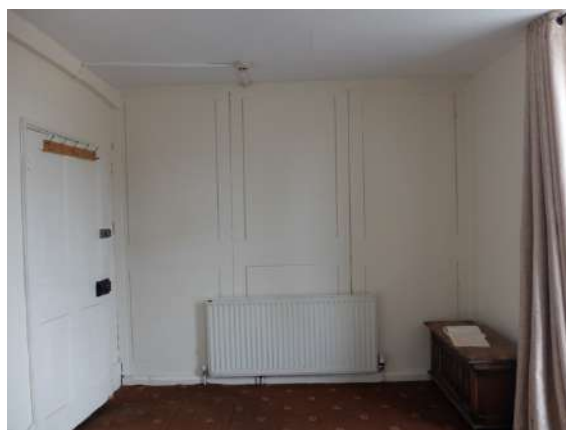
Fig.74 F1 Panelled partition wall dividing the front rooms

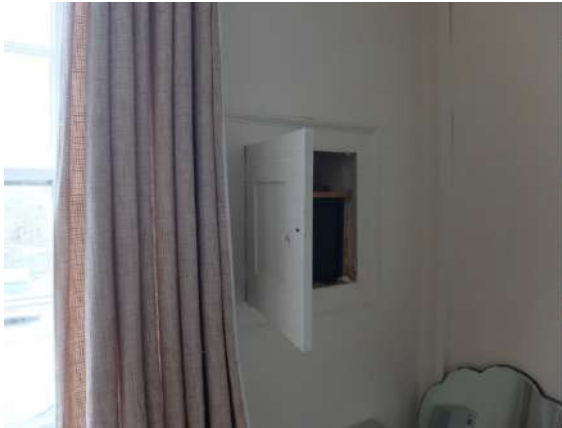
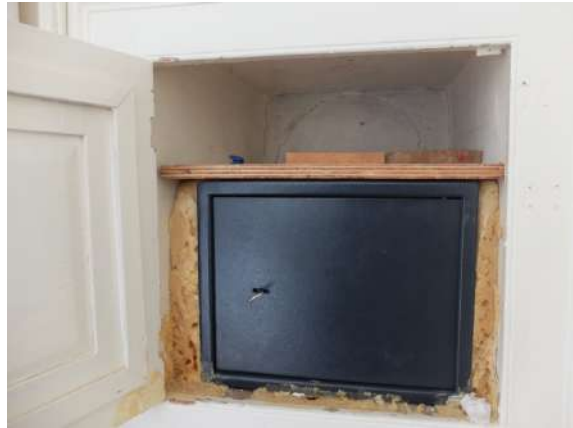
Fig.75 -76 F1 Wall cupboard with safe inserted and outline of oval panel on the back wall.

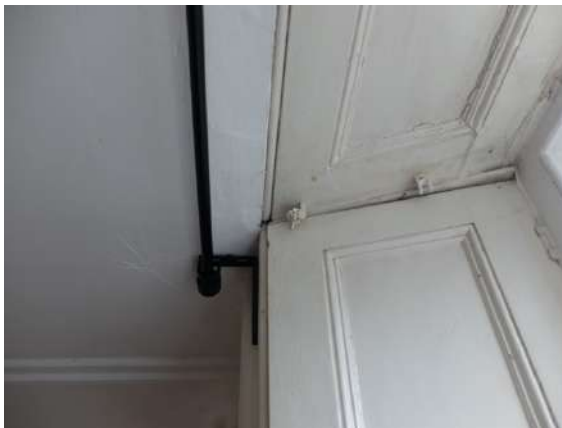
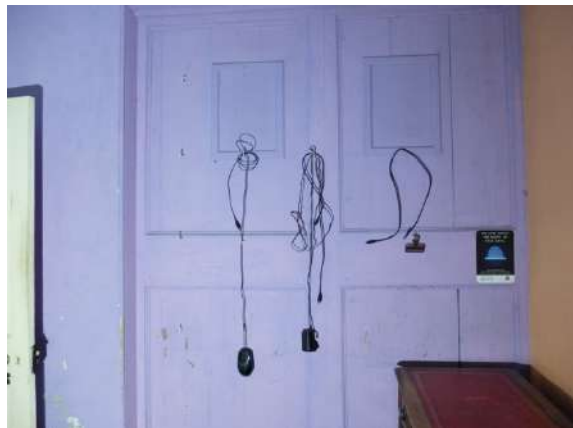
Fig.77 F1 Ceiling panel slightly below window surround

Fig.78 F5 Reverse side of F1 cross wall timber panelled.

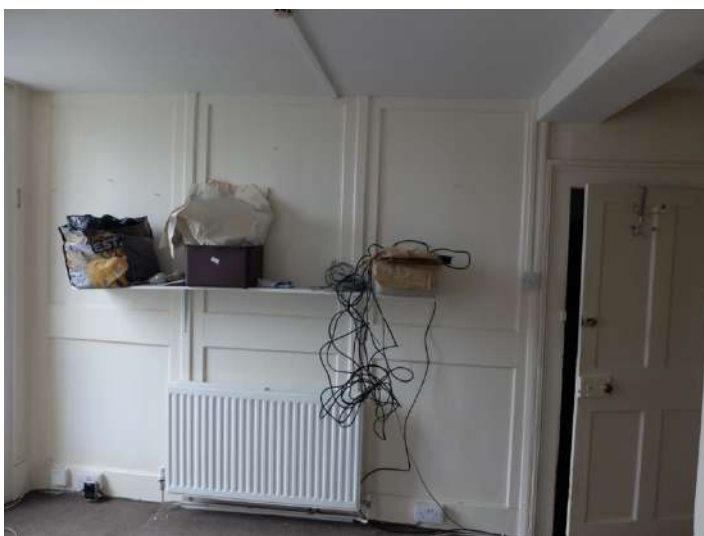
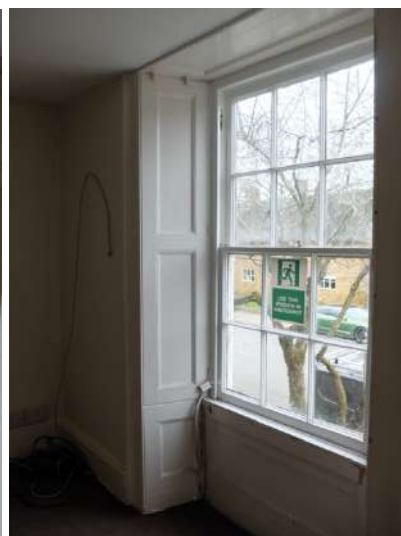
F2: Reception room - SE front-facing. Retains a few elements reflective of its 18th-century origins consistent with F1 - undergone various modifications including partitioning of an irregularly shaped room at the rear and remodelling of an area adjacent to the landing. Pair of sash windows, panelled reveals with concealed shutter boxes and shutters (painted over). The reverse side of the panelled partition that divides the room from F1 has plain recessed panels. Boxed in ceiling beam, possible structural steel aligned with a former cross-wall. Fire door opens onto the landing - a large recess behind and uneven wall finish suggest this is the point where the main stairs emerged at first-floor level.

Fig.79 F2 Reverse side of F1 timber wall panels

Fig.80 F2 Panelled shutter boxes

F3: Room sub-divided from primary F2 space. Rear southern corner is blocked - likely position for a corner fireplace. Uneven section of wall on the rear (indicated by red dash line Fig.79) indicates there may have been a window on the rear wall.

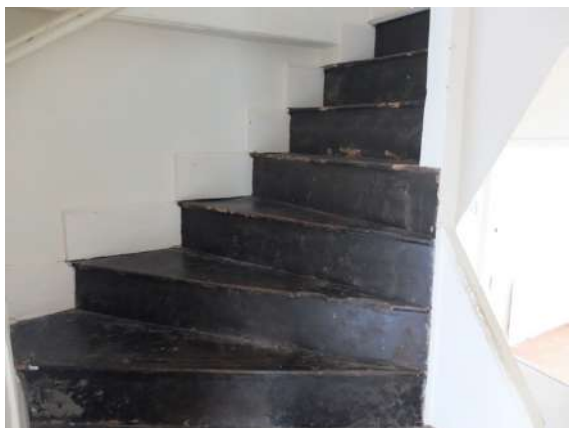
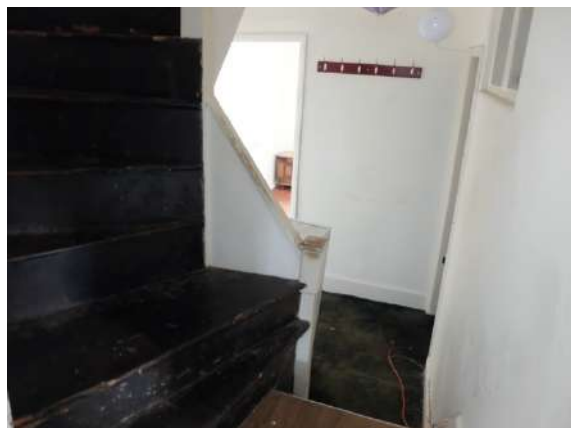
Fig.83 - 84 F4 C19 Stained timber treads to second floor - boxed-in C20 baluster and newel post

F4: First Floor landing - L-shaped joins F8 at the rear. Section of wooden winder stairs to SF with evidence of remodelling at the base and infill section of wall on rear wall [Fig.85], infilled balusters - joinery C20. Doors to three rooms and modern high- level glazed internal window to F5.

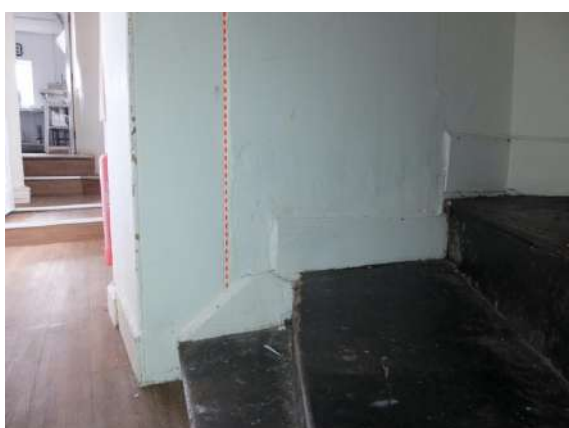
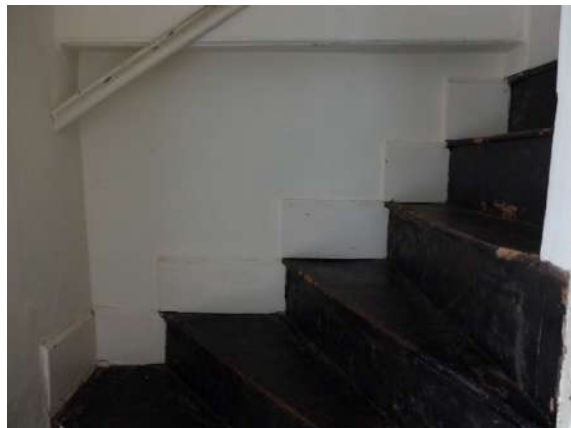
Fig. 85 - 86 F4 Wall extended at base of stairs and recess to side wall

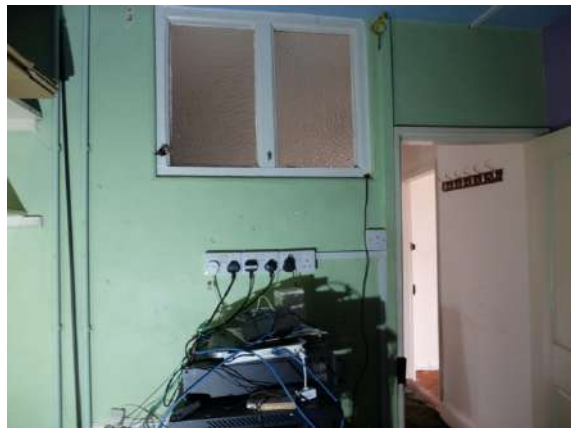
Fig.90 F5 Internal window and doorway to hall F4

F5: Rear room without external window. Raised platform concealing pipework. Concealed chimney breast with an integral cupboard to one side - and rounded plaster walls within suggest this was the location of primary winder stairs built off the chimney breast. Modern two-light internal window to F4 and timber panelled partition to F1.

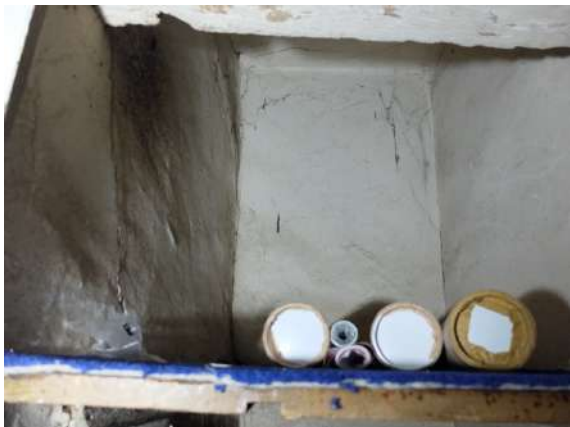
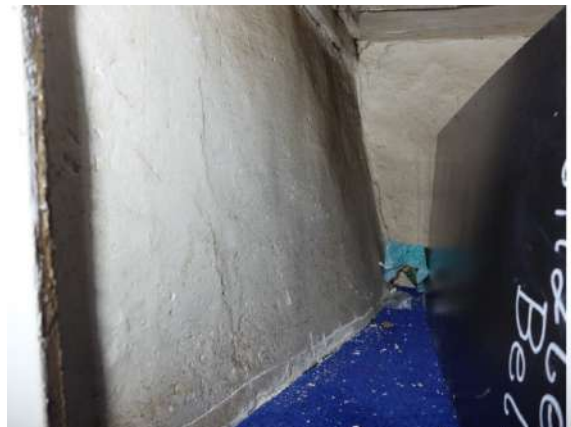
Fig.91 - 92 F5 cupboard interior - uneven masonry, curvature to the chimney breast side wall denotes C17/C18 staircase

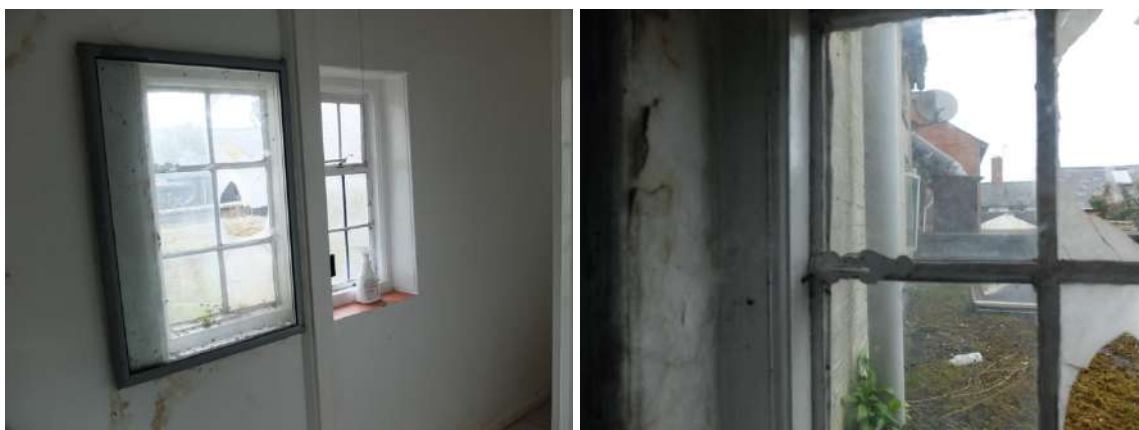
Fig.93-94 F6 Casement divided by partition - metal casement LHS and modern timber RHS - turnbuckle catch c.1700

F6 & F7: Toilet and shower with short corridor. Casement windows on northern wall divided by partition to toilet. Left-hand side metal casement with decorative turnbuckle catch [Fig.94] [L. Hall Period House Fixtures & Fittings 1300 - 1900, P.91 Fig.3.55 1698 *Glos.*].

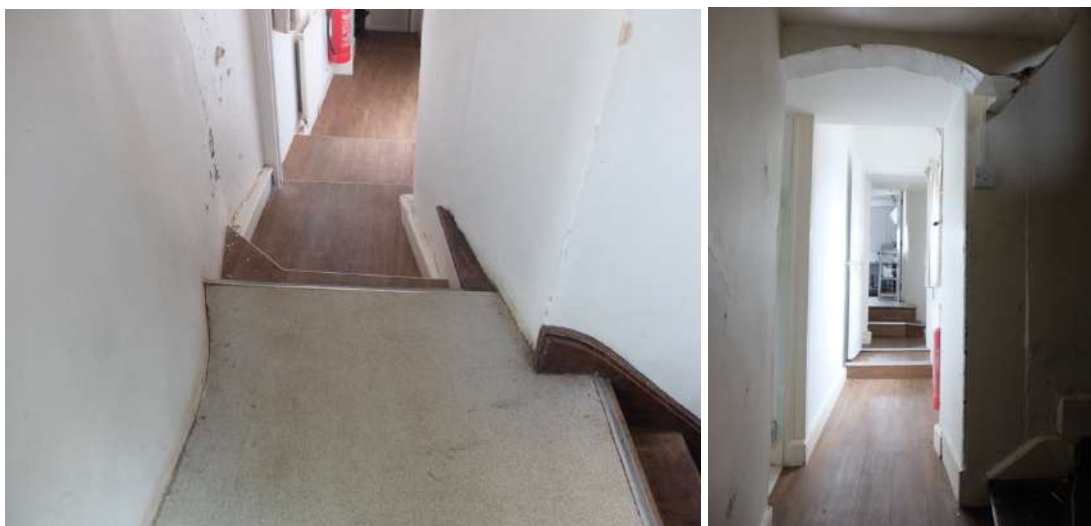
Fig.95-96 F8 Three changes in level landing area - seen from east to west and then in reverse - note bottom step to concealed staircase RHS of Fig.93

F8: Corridor with 4 step changes to F4 landing. First step of the attic stairs is visible at the base of the blocked wall on the north side of the corridor at the top of the wooden stairs from GF (F9).

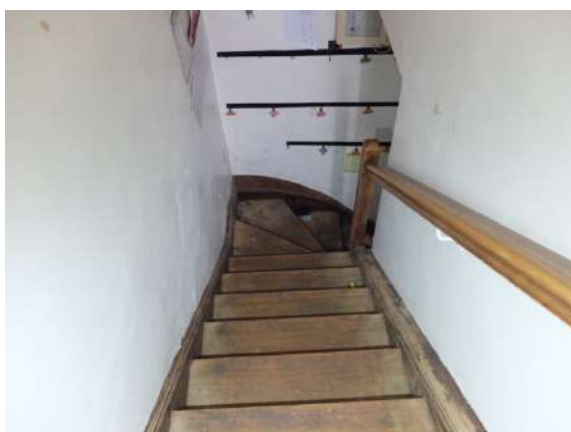
Fig.97 F9 C19 wooden stairs from G7 to F8

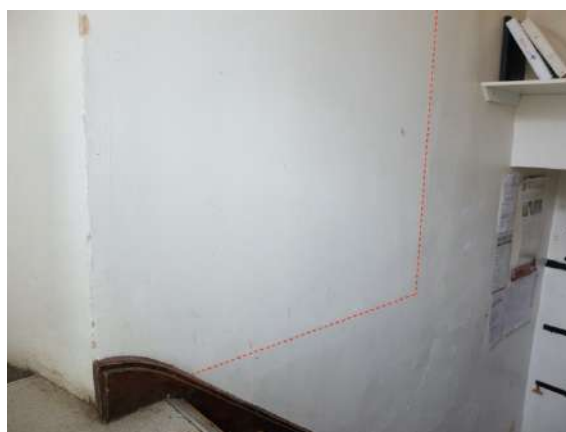
Fig.98 F9 Top of stairs uneven wall section indicated

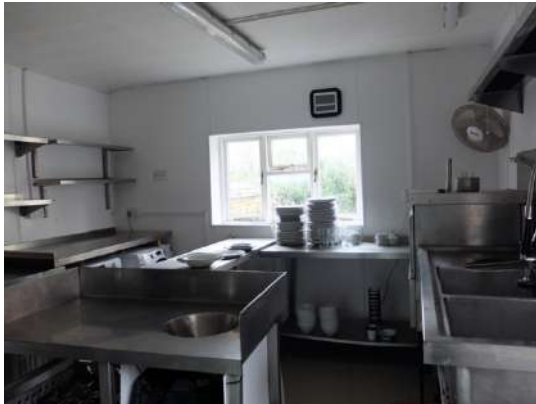
Fig.99 F10 Service room

F10: First-floor room in use as a service area to the kitchen below (G7). Modern three-light top hung window on east-facing gable end wall. Side casement window divided by door/wall partition with single opening casement corridor side and two-light opening casement F10 side. Small recessed cupboard behind the stairwell with older joinery.

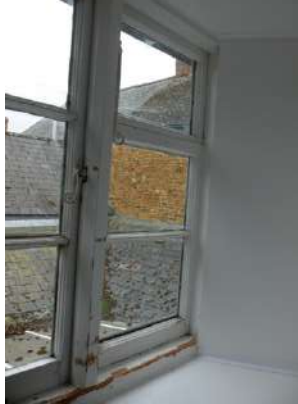
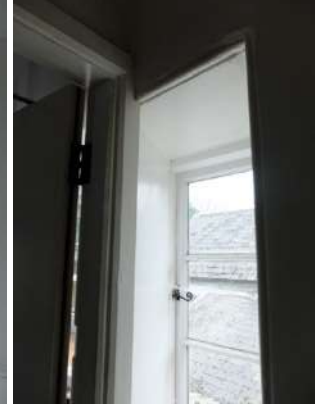
Figs.100-01 F10 - F8 Divided casement window

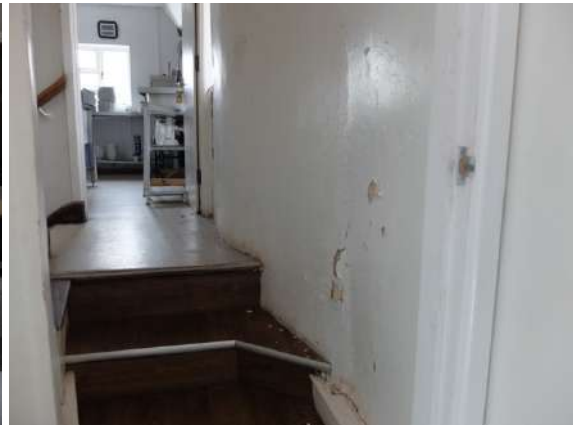
Fig.103 F8 to F10 cranked side walls

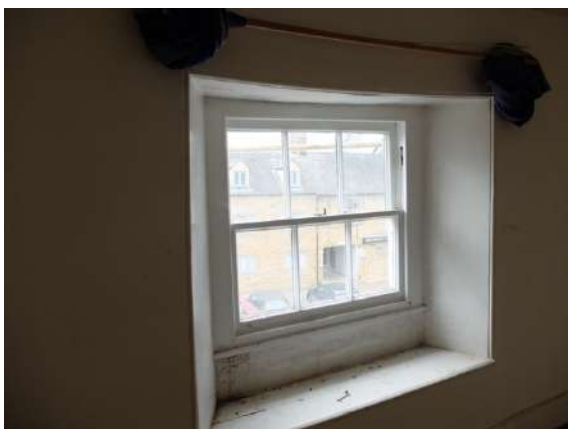
Second Floor: S1: Front room NW with pair of six-paned small sash windows within deep plain reveals and lowered sill/window seat. Two painted roof truss ends visible. Southern window curtailed with slanted partition to create walk-in cupboard accessed from S4.

Fig.104 - 105 S1 Sash windows inset with deep reveals - side wall angled to accommodate walk-in cupboard from S4

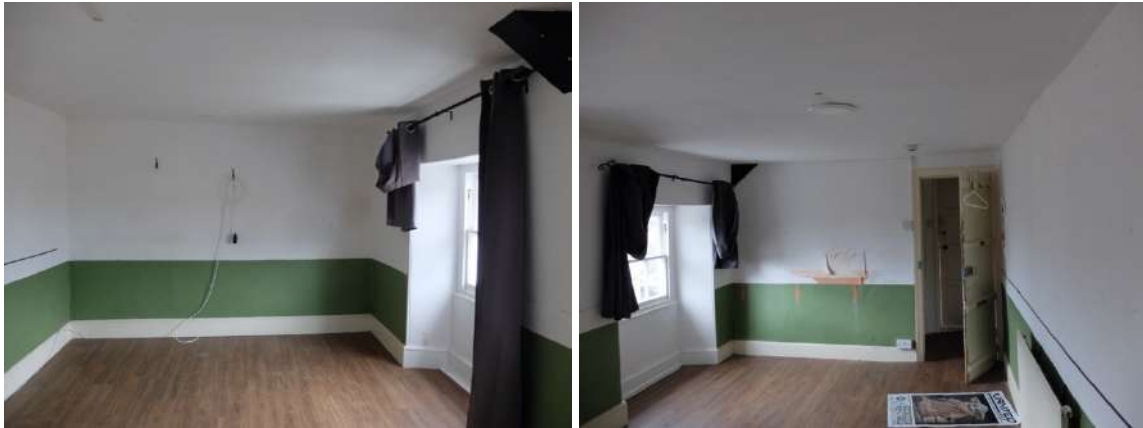
S2: Front room SE with a pair of six-paned small sash windows within deep plain reveals. Two painted roof truss ends are visible.

Fig.106 - 107 S2 SE Front facing room with vinyl floor
