HERITAGE STATEMENT

CROWN AND TUNS NEW STREET DEDDINGTON OX15 0SP

Prepared for Josh Cowdery and Stephanie Aspin, Crown and Tuns, Deddington, OX15 0SP.
By Wendy Tomlinson MSc, PG Cert (OXON), IHBC.

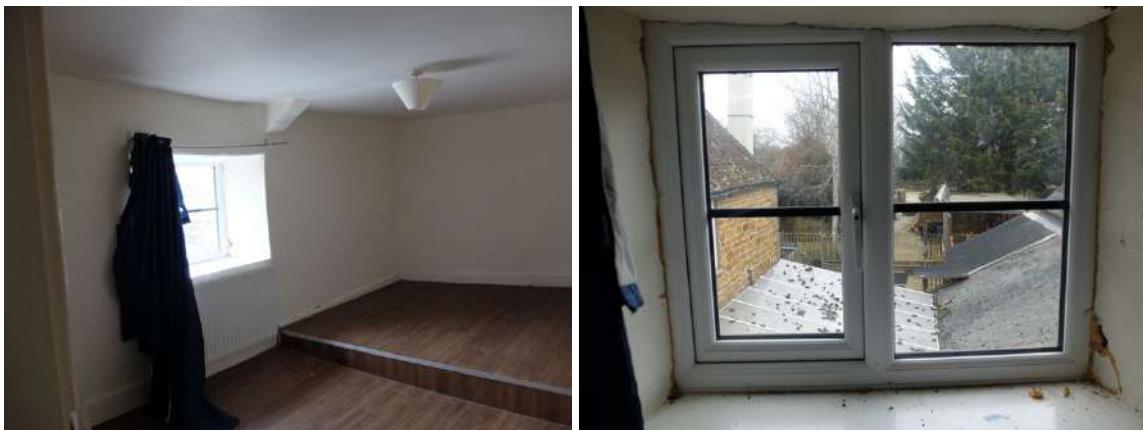
S3: Rear room with raised dias, modern UPVC two-light casement to rear and roof truss end painted and visible. Vinyl 'wood-effect' floor.

Fig.108-9 S3 Rear room with UPVC casement centrally positioned on wall with an outlook across rear yard.

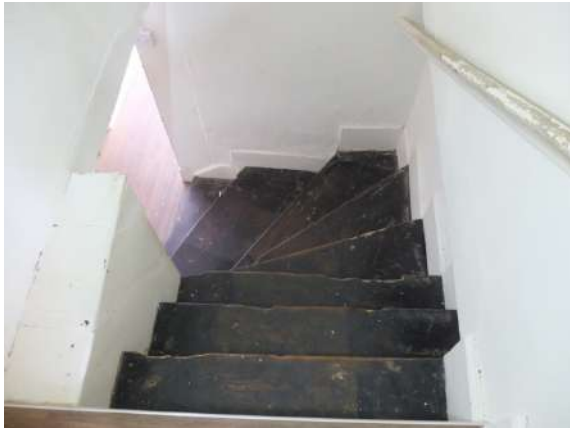
S4: Top landing area. Linear with two rooms to either side and a walk-in cupboard at the end. Ceiling hatch above with a limited view of roof space. Room partitions, door openings and doors have been remodelled [Fig.112].

Fig.110 S4 landing and stairs

The plan form on this level does not correspond with the lower floors: S1 and S5 together are wider than F1 and F5 suggesting that the roof structure over the main range was rebuilt probably when a rear range was first added mid-to-late C19.

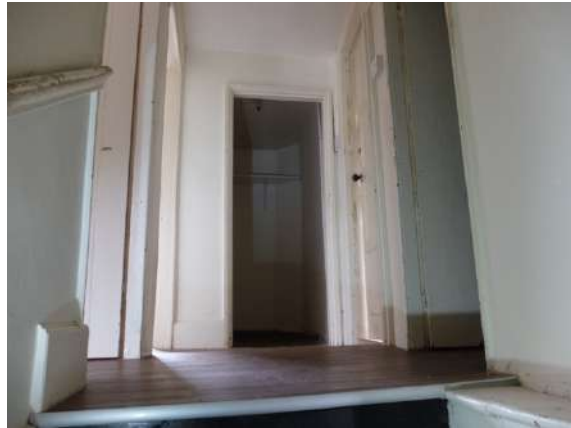
Fig.111 S4 Walk-in cupboard between S1 and S2

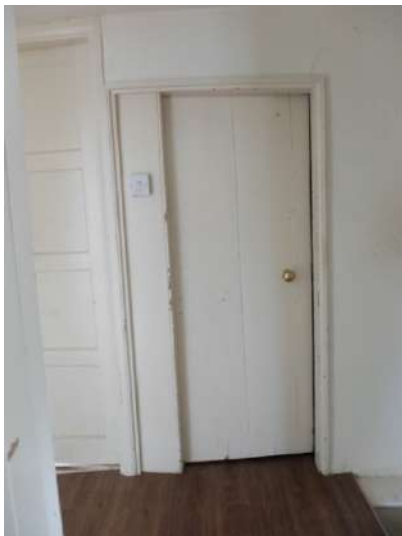
Fig.112 Altered door opening

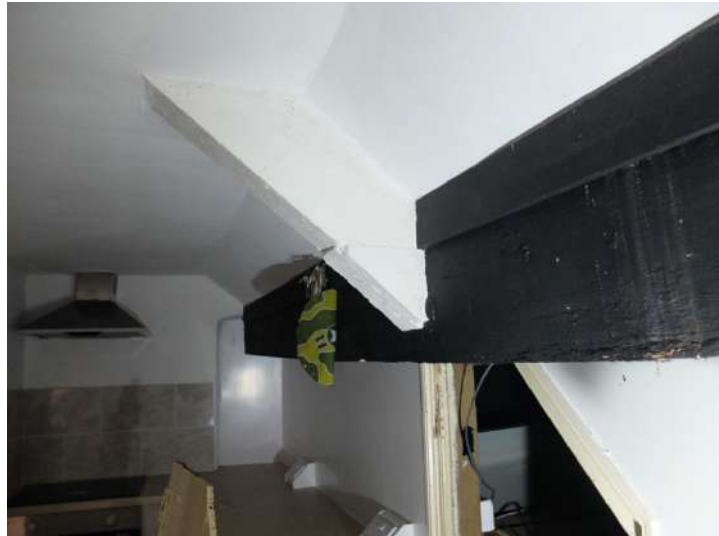
Fig.113 S5 Exposed truss feet and purlin

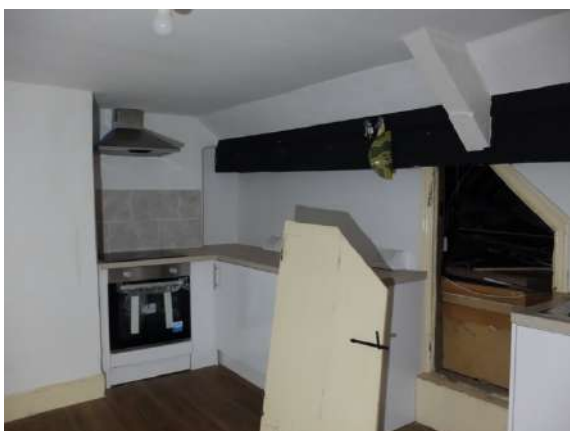
S5: Rear room without window. Reinforced purlin painted black and truss feet painted white. Steps up to raised opening into a roof void over the NE rear wing. Modern roof structure raised significantly higher than historic roof. Chimney stack midway, with melange of blackened brick, stone and daubed render indicating earlier form with later brick infill to either side. Roof structure continues beyond stack.

Fig.114 S5 Raised opening to roof void

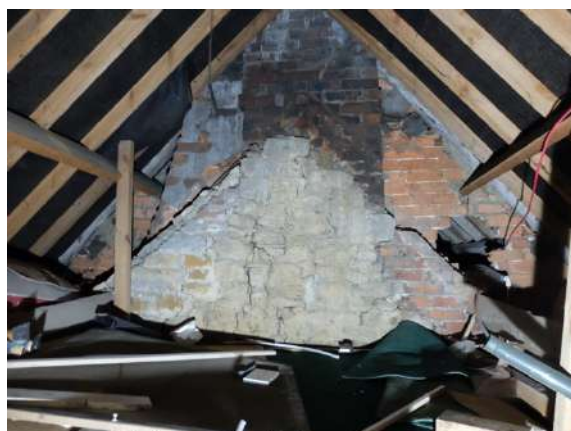
Fig.115 Fabric in roof void demonstrating lower roof pitch

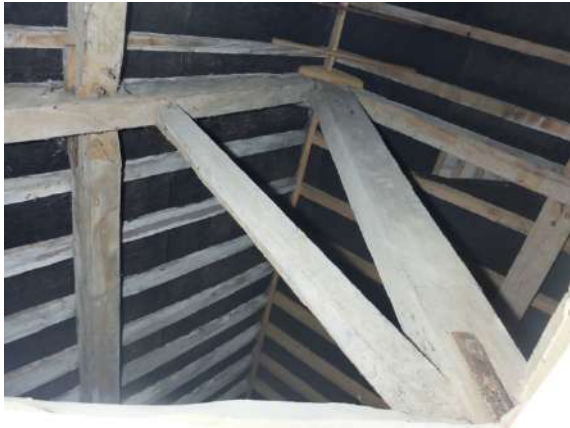
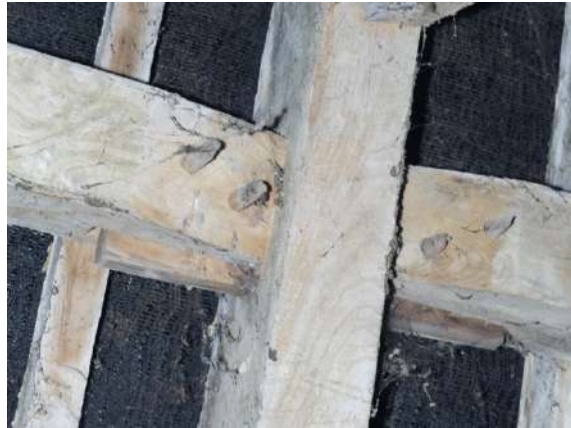
Fig.116 - 117 Butt-purlin roof construction with machined timber king post roof truss and metal plate reinforcement

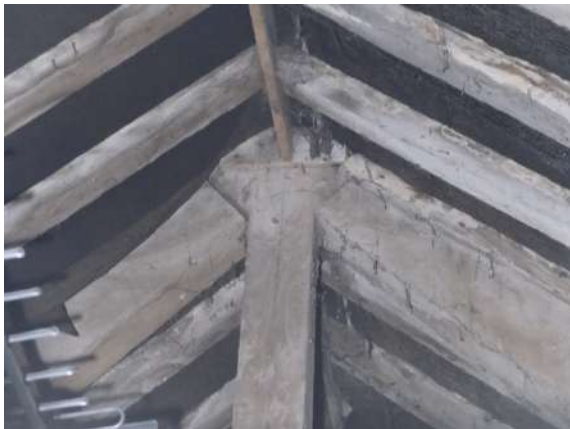
Fig.118 Ridge plate or plank set square

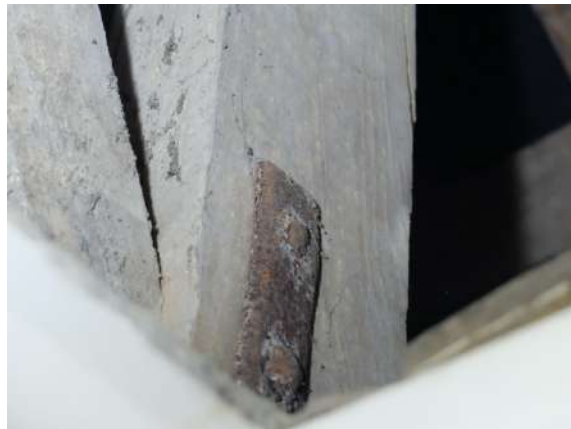
Fig.119 Iron plates and bolts used alongside pegs.

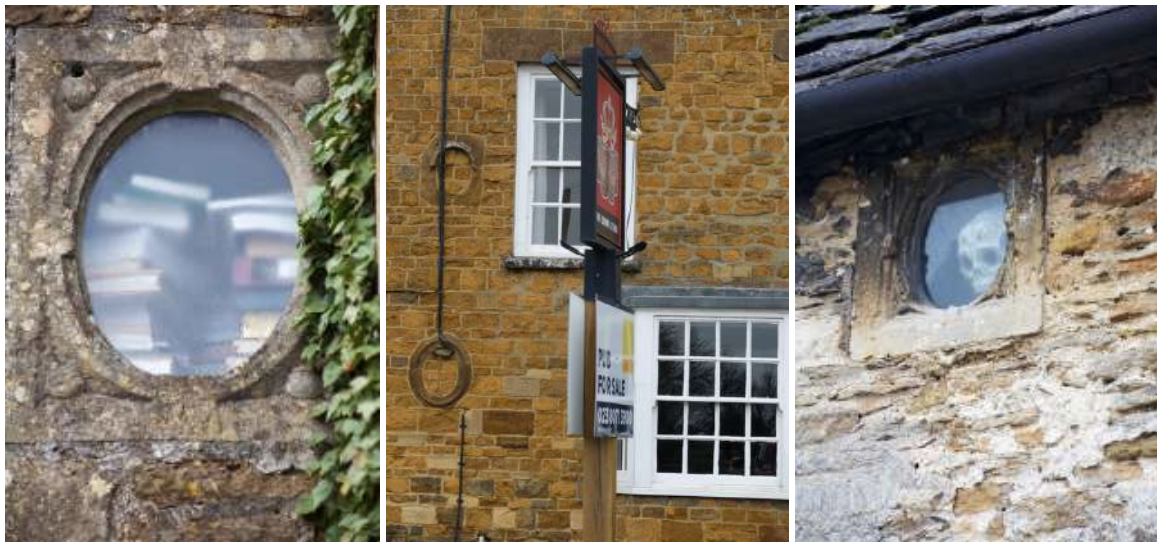
Fig.120 - 122 Early C18 Oeil-de-boeuf windows compared to those found on the front elevation of the Crown and Tuns.

7.0 Discussion: The Crown and Tuns has had many phases of adaptation and extension to meet the operational needs of an inn over the last 250 - 300 years. Many of these interventions—particularly those of the 20th century—have obscured or compromised the historic plan form and spatial legibility of the building. There are some dateable features, but they may have been reused from an earlier iteration of the building, on the site or elsewhere or be an example of an old-fashioned vernacular tradition. For example, the metal framed casement window in F6 with a turnbuckle catch c.1700 is located within a C19 extension, and the oeil-de-boeuf oval windows have a broad date range from late C17 to early C18. Plain hand-forged L-hinges are found on a re-purposed plank and batten door in the attic and these date from the early C18 [L. Hall Fixtures and Fittings in Dated Houses 1567 - 1763 P.75] but continued in use in rural areas well into the C19 century.

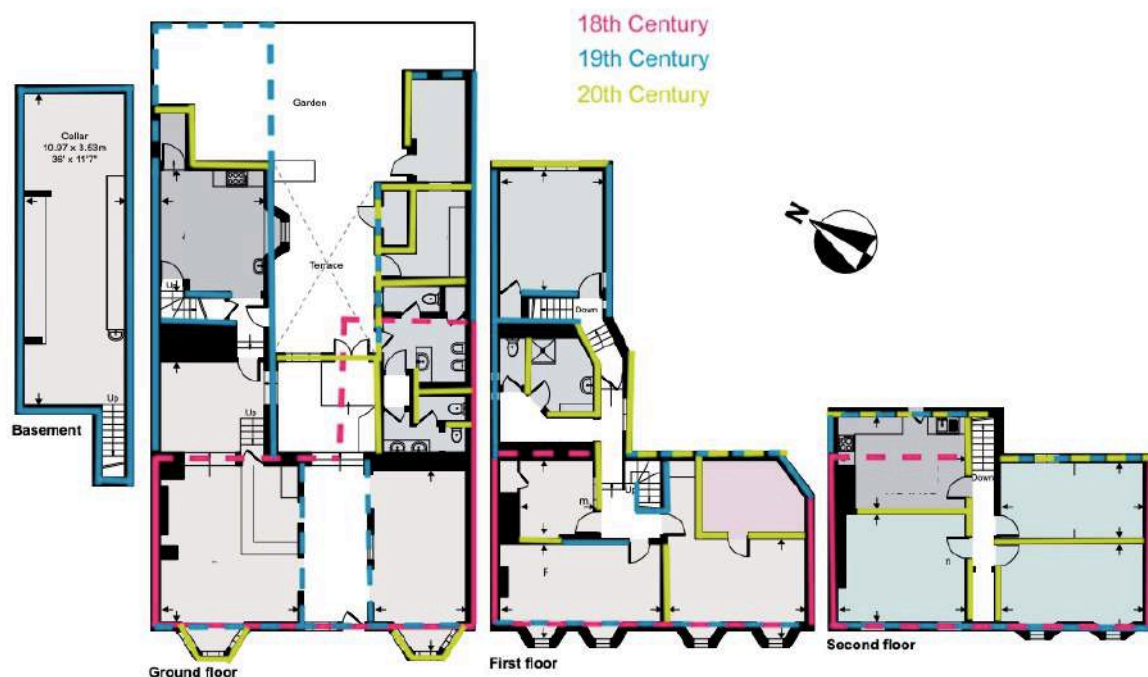
Fig.123 Phased plan showing the development of the 18th-century building to its current plan form
