# DEDDINGTON MANOR, OX15 0SR HERITAGE AND IMPACT ASSESSMENT

MAY 2022

JAMES  
MACKINTOSH  
ARCHITECTS

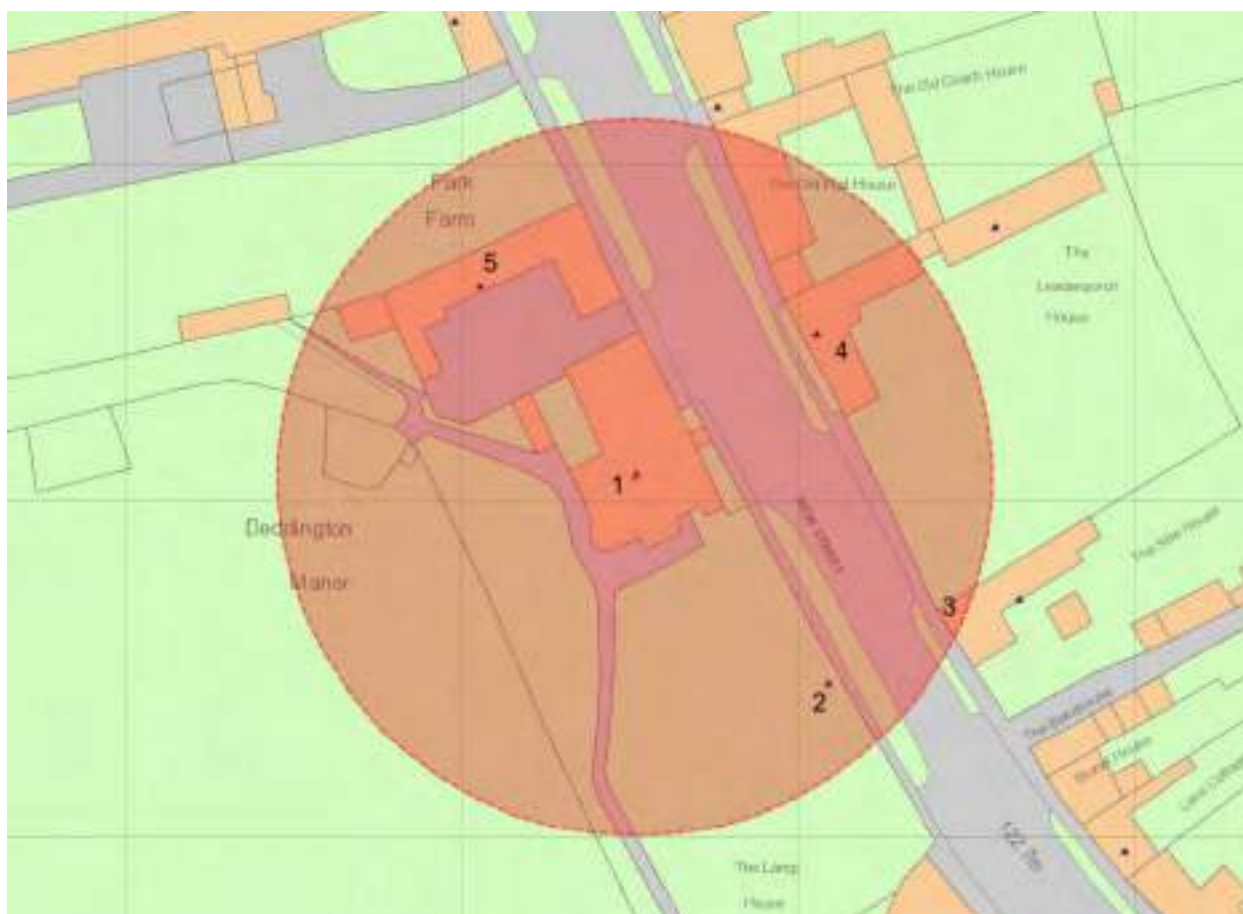
Fig.2 Designated heritage assets within 50M of Deddington Manor

DESIGNATED HERITAGE ASSETS WITHIN 50M		
1	DEDDINGTON MANOR, NEW STREET	Grade II
2	PARK WALL TO SOUTH OF DEDDINGTON MANOR, NEW STREET	Grade II
3	THE STILE HOUSE, NEW STREET	Grade II
4	THE LEADENPORCH HOUSE, NEW STREET	Grade I
5	WALLED GARDEN STABLE BLOCK AND ATTACHED WALLS TO NORTH WEST OF DEDDINGTON MANOR	Grade II

A desktop study of the designated heritage assets within 50m of Deddington Manor House has identified four listed buildings or structures nearby, three of which are within the curtilage and same ownership as the Manor House. The site lies within Deddington Conservation Area which consists of a high number of designated heritage assets reflecting the special architectural and historic interest of the area in general. Nearby assets shown on the map below are those most likely to be impacted by changes to the site and their list descriptions contribute to our understanding of how the study area developed. The list descriptions of the identified designated heritage assets are recorded in Appendix A and the list entry for the Manor House is given below.

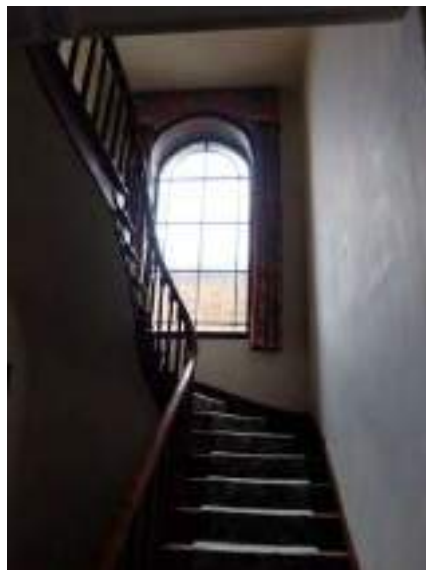
Fig.8 Franklin's oak staircase

Underwood's addition was built to match exactly the previous construction, with ashlar stone to the west and square coursed rubble to the north elevation. The new oak staircase was prepared at Franklins' yard in Deddington. Franklin's were a newly established local building firm based in Chapel Street. Robert Franklin was a highly skilled carpenter and carver who made his reputation doing new and restoration work for churches. One of his early employees was Joseph Hopcraft who founded a successful building firm and like Franklin's, their firms were multi-generational with their sons continuing the businesses well into the 20<sup>th</sup> century. Joseph was a mason and Hopcrafts, later owned the local brickworks which operated for the latter half of the 19<sup>th</sup> century.

Together, Franklin and Hopcraft worked on Deddington House under Underwood's instruction. By comparison with the building work, the carpentry work took some time to complete. Risley called at Franklin's yard to look at the preparations first on the 3rd December and then again on the 17th March, when it looked "well and handsome", the installation was completed at the end of April and included a "Venetian window" half way up on the bend of the flight. The staircase was made from a "Chesterton oak" which Risley had bought some years before and had had sawn up in his saw-pit (Fig.8). All the woodwork

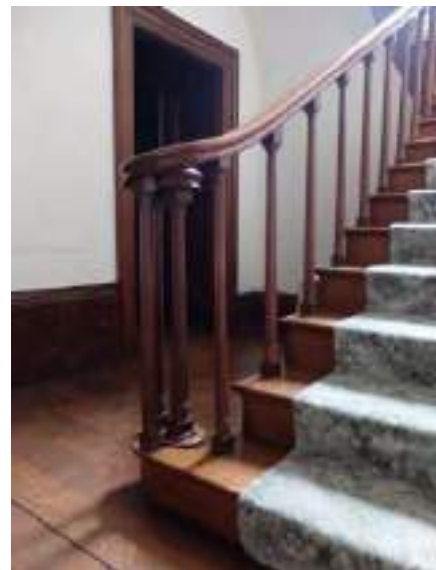
Fig.9 Fluted balusters

string with a straight profile, tread-ends are adorned with a plain curve, the steps arranged in a continuous winder to the first floor. Balusters are fluted columns with plain capitals and plinths, the rounded hand rail terminates on a curtail step with a cluster of supporting balusters. First floor arched window with clear margin lights on the return complete this grand set-piece (Fig.8). Oak was used only for the grandest of staircases and this addition helped to elevate the status of the house from a farmhouse to that of a wealthy landowner.

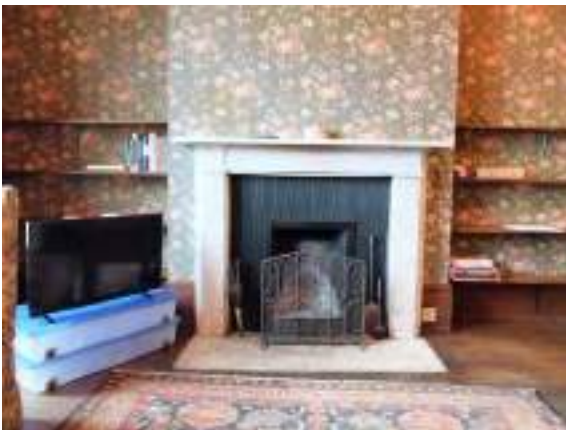
Fig.10 Grimley fireplace G10

in the new rooms, including doors, windows and floors, and the adjacent hall and landing areas were made from this oak. Marble fireplaces were by Grimsley of Oxford and were installed in both of the new rooms (Figs.10 and 11). Thomas Grimsley described himself as a sculptor in the 1841 census, which is the year that he produced work for Deddington. He is listed as a "Stone & Marble Mason\*" *\*also statuary* in Hunt's 1846 Directory, and he exhibited a terra-cotta statue of a female figure at the Great Exhibition 1851 which received a commendation from the judges. The company later concentrated on church and monumental work of some distinction as well as the owner of several brick, tile and pottery manufacturing patents which included terracotta drainage pipes. The two fireplaces at Deddington are the only mention of domestic work in a biography of his company<sup>7</sup>.

has been added which connects the fire opening (stove) in the front reception hall G1 with this stack. G10 and F10 (Figs.10 and 11) are served by one stack on the south gable of Risley's new wing, and a slim single stack appears to have been added to solely serve G9 (Boot Room), possibly the location of a Butler's Pantry which presumably required heat for household purposes. An additional (modern) top-hung window on the west wall indicates where a door once connected to the conservatory (Fig.37).

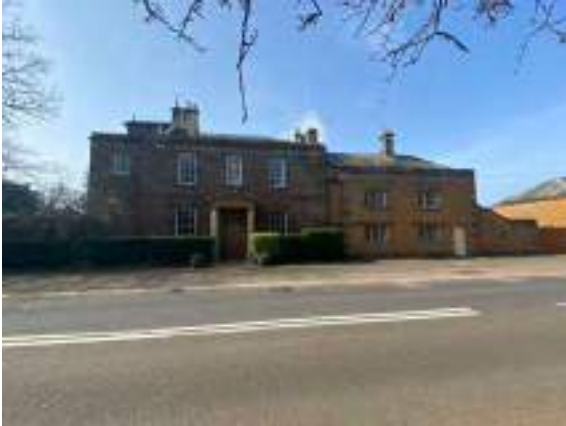
Fig.17 Front elevation

**External:** The front elevation of the site is parallel to the street and consists of a stone boundary wall attached to the main range which is two-storey in height with a central attic block (three-storeys to the side south facing elevation) (Figs.17 and 18) and a service range on the north side, swept boundary wall, double timber gates and a separate two-storey L-shaped stable block on the same building line as the main range (Fig.20). The attached service range and detached stable block are built in coursed rubblestone with ashlar quoins and hipped slate roofs. The main range is faced in the same Hornton stone but it is ashlar finished. The central range is symmetrically arranged with three bays, six over six sash windows, ground and first floor, and a Doric porch with a triangular pediment above. A fourth bay is recessed on the south side with a matching sash window on the first floor only. This is a later infill section added in the 20<sup>th</sup> century.

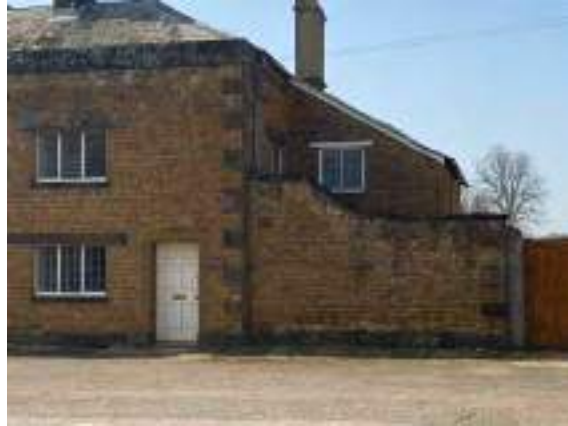
Fig.18 Service range front elevation

The service range has three-light leaded, casement windows to the front on the ground and first floor with a modern six-panel front door inserted on the north (Fig.18). A tall, narrow arch, infilled in matching stone with a two-light casement on the ground floor marks an earlier entrance with a boot scrapper still in place (Fig.23), the door at the north end was inserted in 1970 when one ground floor room at the front and the rooms above were converted into a self-contained flat. Set back behind the boundary wall is a single storey lean-to, immediately abutting the boundary wall (Fig.21) and a further two storey lean-to has been added to the rear of the side elevation (Fig.19 and 24). Two storey outbuildings, formerly stables enclose the north side of the service yard (Fig.20): the building that fronts the service yard is L-shaped with an infill section of stone work (not matching) nudged into the corner, a single plank door below and the return is in brick. Wide timber garage doors open on the west face onto the yard and tall double, barn style doors are on the brick return (Fig.25). Attached and running along the north side of the yard is a slightly lower range, the former stables, that step out for one and a half bays at the west end. Fenestration is a mix of leaded, casement style windows, doors are timber plank with leaded lights above with several roof lights inserted into a slate roof, hipped at the west end. A high boundary wall on the west flank of the yard has a timber ledge and brace gate centrally placed with an inset window to one side, beyond this is the former

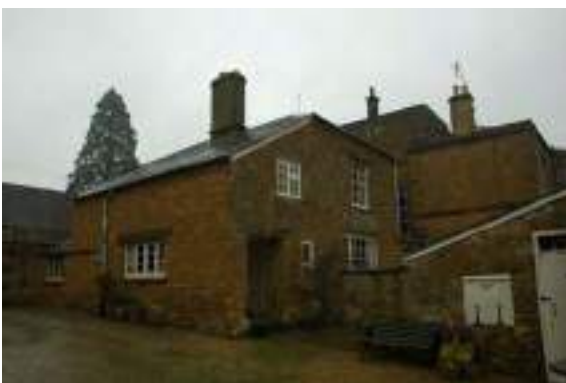
Fig.19 Rear two stage service range

Between the outbuilding and the rear elevation of the service range there is a path leading to a wide garden gate set into the boundary wall which leads to the main garden (Fig.24). The rear elevation of the service range has a single storey infill section in brick with a modern sash window and half glazed door to one side, plastic guttering and a second storey set back with three sash windows, two matching, six-over-six and the third, four-over-four above (Fig.22). A further external door is set within an open porch at the north end which also contains a WC. The flank wall of the service range has a dummy three-light casement at ground level on the single storey lean-to adjacent to the front boundary wall (Fig.21 see also Fig.47), and on the two-storey lean-to, a four light casement window under a deep stone lintel with security bars on the inside face of the window on the ground floor, blank above (Fig.19).

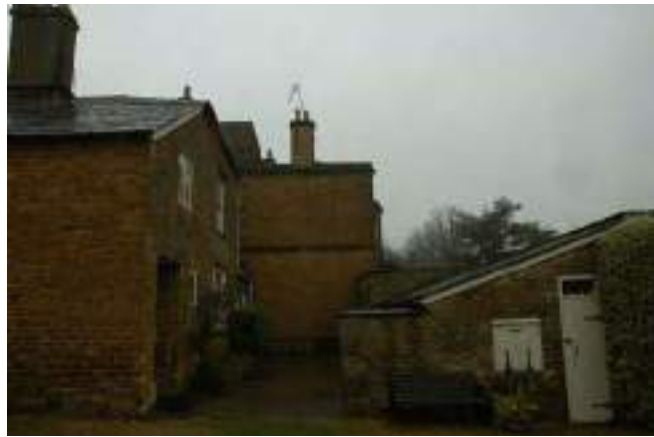
Fig.24 Service range and outbuildings

Kitchen Garden and Icehouse (Fig.26). The ground level falls away in front of the door. The south side of the yard is formed by the single storey wall of an outbuilding that lies parallel to the house (Fig.24).

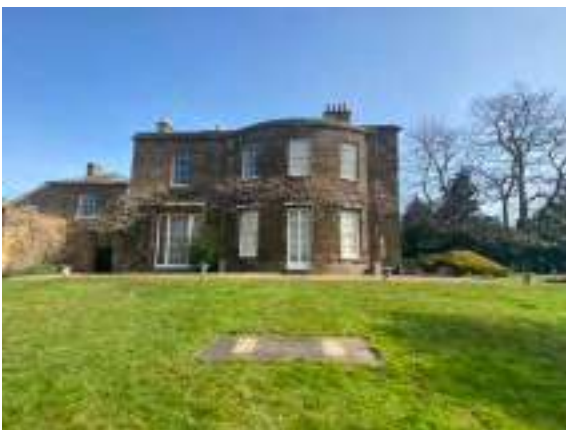
Fig.27 Rear west facing principal elevation

The rear, west facing elevation of the main house consists of three bays: a two-storey, single bay on the north end; on the south a broad, three light shallow curved bay; and set back from the building line is a single, three-storey bay that projects south (Fig.27). The first bay has full-length tripartite sash windows at ground level and six-over-six sash at first floor. Second bay has elongated sash windows to either side of narrow French doors. External sun blinds and awnings over the ground floor sash windows and French

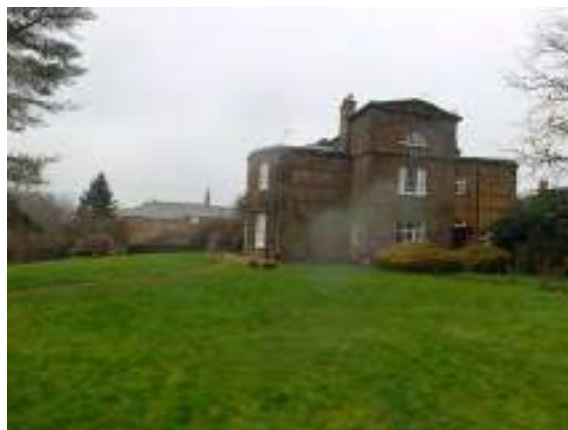
Fig.28 South west elevation with additional attic storey

The south facing elevation has a central projecting bay, three-storey incorporating the attic storey with a large, half-round Diocletian picture window on the top floor and a tripartite sash window with margin lights below over a wide glazed French door on the ground floor (Fig.28). To the side of which and set within a recess is an entrance door over which is a flat stone hood on moulded corbels with a three-light overlight above (Fig.30). The door is half glazed with two panels in relief below. Two matching modern sash windows are on the east side of the door which match a first floor window above the side entrance door. Rectangular decorative fielded panels adorn the otherwise blank first floor walls to either side of the central bay (Fig.28).

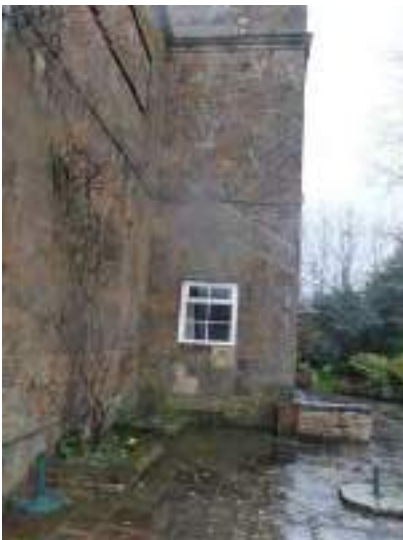
Fig.29 Scars left by conservatory

doors on the west facing bays are rare survivors. Within the third bay, west elevation is a modern top hung window at ground level which has taken the place of a door. Scars in the stonework show where previously there was a lean-to conservatory, stone paving in this area has also retained evidence of the conservatory's footprint (Fig.29). Elsewhere the ground surface immediately surrounding the house is gravel and laid to lawn on two sides.

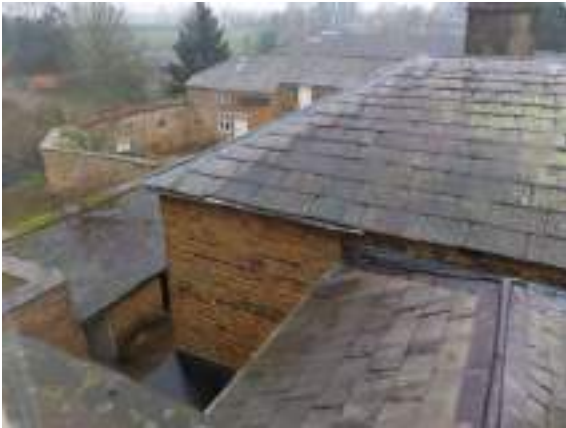
Fig.31 Slate roofs over service range

Pitched roofs in slate (Fig.31) are concealed behind parapets on the main range, with hipped roofs constructed in sections to the front and rear of the central attic block and surrounded by lead valley gutters. The exception is to the south, where the external wall rises straight up (Fig.28). The front, south side and rear (west) elevation of the house are all faced in Hornton ashlar stone with fine mortar joints. There are seven separate chimneystacks serving at least 17 existing fireplaces (17 pots have been counted). Most are constructed in ashlar regardless of whether they are located on the main house or the service range, with one over the service range serving the Kitchen G8 and bedroom above F8 rendered.

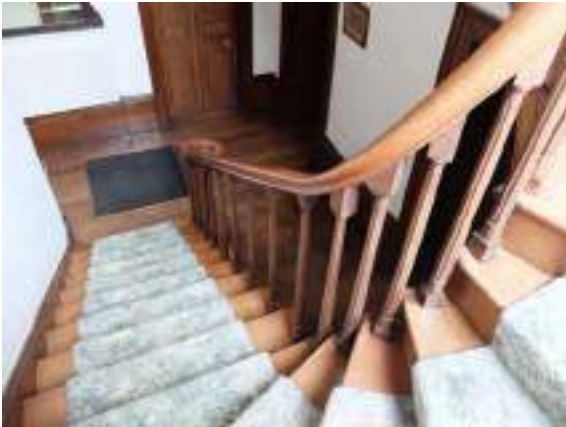
Fig.33 Main staircase, ventilation grill at foot of stairs

**Ground Floor:** The main entrance (portico) leads into the Entrance Hall, oak flooring, door surrounds, doors and high plain skirting are all in richly stained polished timber (oak). To the rear the main staircase (Figs.8,9 and 33) is positioned crosswise and is set one room back, a door adjacent to the staircase on the east leads to a service corridor, off which is a back stair that connects at the first floor with a section of the earlier staircase, this is demonstrated by its additional width compared with the narrower flights between the floors. Large reception rooms are disposed off the rear hallway on the south and west. At the foot of the stairs is a large metal ventilation grill set in to the floor (Fig.34). The staircase in polished oak is open

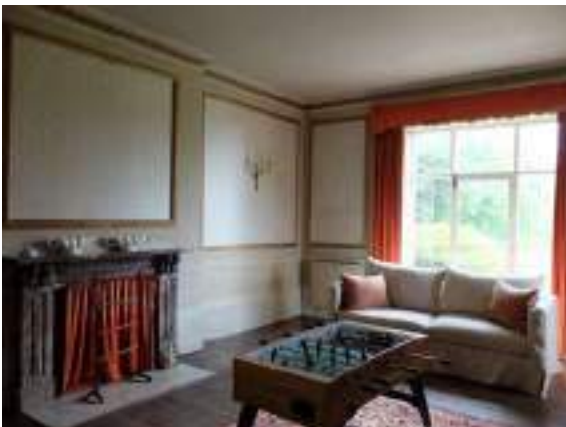
Fig.35 G2 Fireplace on east wall, glazed doors to garden

Fireplaces and chimney locations are interesting indicators of change within the building: G2, extended and rebuilt by Risley probably previously had a chimney on the end, external gable. A new one was added on a crosswall allowing for doors out to the garden (Fig.35), this new chimney also served the attic room S2 (Fig.39), which with its Diocletian window (Fig.40) was clearly intended for use by Risley or other family members rather than as servants quarters. F2 is served by a fireplace on the opposite crosswall (Fig.38), and concealed flues from G11 and F11, new additions in 1841, feed into the stack. More recently a metal flue

All three of the principal reception rooms on the ground floor have large full length windows or doors offering views and access to the garden demonstrating the historic importance of the inside and outside established by Revd Risley in the 1840s (Figs.35 and 36).

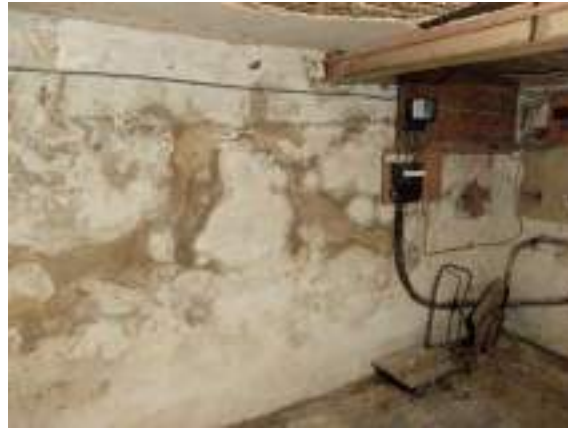
Fig.42 C5 plastered walls, concrete slab floor and RSJ

There is a small cellar C5 under the northern front room of this wing, and a larger one under the inner hall and dining room of the main block C2-3. This latter one contains evidence that it was used as a wine cellar with wooden struts and brick plinths used to support beer barrels (Fig.44); it now houses the boiler (Fig.45) and redundant equipment from earlier heating schemes. C5 may have been accessed from a block doorway in G8, the Kitchen. Stairs were added to G5 to provide a separate access to the first floor (Fig.41) in the 1970s when it was used as a staff flat. Plastered walls, concrete flagged floor, a RSJ and a modern window all show that C5 was re-worked and strengthened in the 20<sup>th</sup> century (Fig.42).

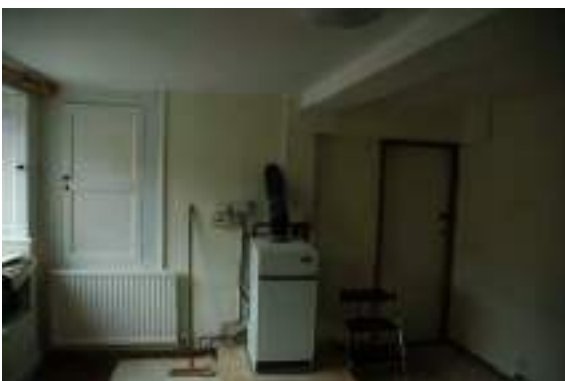
Fig.48 Chimney recess cupboard G5

fireplace between G4/G5 that this area functioned as an earlier kitchen with a range set into the chimney on the north face of G4. This may have been an end gable wall - a deep cupboard within the chimney breast opening to G5 shows the depth of the wall and the cupboard may have been reversed or added to enclose an earlier door opening (Fig.48). The concealed chimney breast G4/G5 now serves G5 and F5 (Figs.48 and 51), and a fire opening and surround has been placed on the south wall of G4 to use the flue that originally served G1A. G1A originated as a higher status room than a Laundry and was built/re-built as a principal room late 18<sup>th</sup>/early 19<sup>th</sup> century as shown by the shutters, sash window and height of the room which corresponds with the other principal spaces on the ground floor.

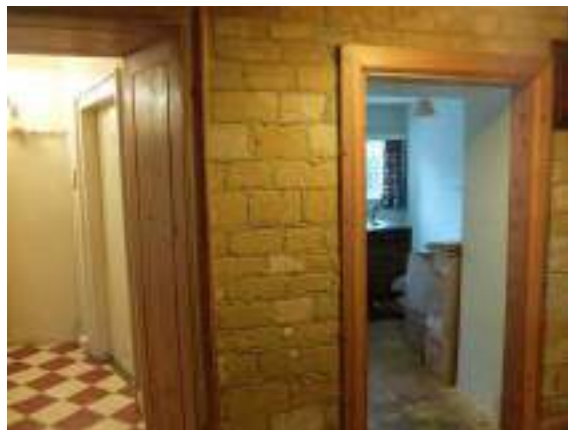
Fig.53 Service corridor exposed stone blockwork

Exposed stone blockwork on the face of the corridor wall has an unusual 'piped' pointing style, door frames and doorcases appear to be recent renewals to match stripped pine joinery that dominates in this range (Fig.53), six and four panel timber and half-glazed historic doors access rooms to either side. A canted door opening to G4 is a later insertion and may be related to the re-working of the entrance to the cellar C5. Stone flags in G4 show signs of having been relaid due to the lack of worn or trafficked areas.

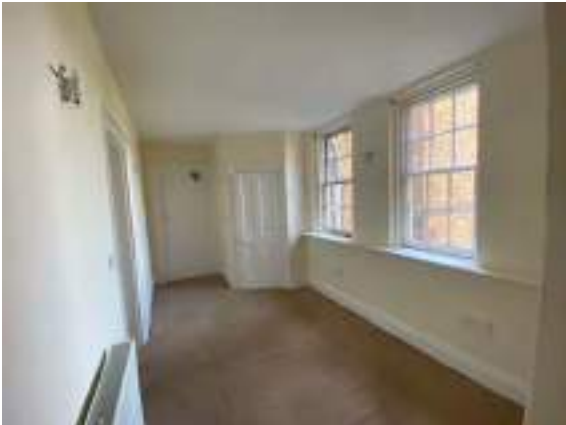
Fig.58 Study area F9A WC in corner

The suite of rooms above the service rooms formed a self-contained flat in the 1970s consisting of two bedrooms, a sitting room, kitchen, bathroom and a study area formed out of a corridor with a WC inserted across a corner. Externally the study area F9A and the Boot Room G9 is expressed in brick, which is likely a re-build (see Fig.22) that took place when the flat was configured – it is not included in the listed building and planning applications (70/00064 and 70/00010) but appears to date from the same period. The Boot Room may have replaced a 'Butler's Pantry' mentioned in several listings for the house and the first floor corridor, now increased in width was likely dark and narrow but necessary to connect the principal bedrooms with the 'nursery wing' as it was previously referred to (Fig.58).

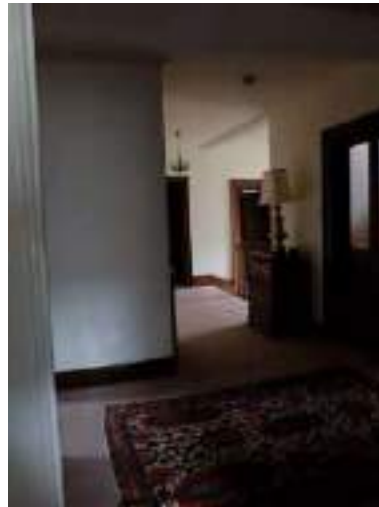
Fig.60 'Squint' door to F11

**First Floor:** The principal bedroom suites are all accessed from the landing reached from the main staircase, which features oak door surrounds and panelled doors consistent with Franklin's 1840s work as part of Underwood's scheme for Revd Risley. A squint door formed in a constricted space near the head of the stairs provides access to F11, Risley's additional bedroom. The main landing area has been reduced in width by the addition of a linear walk-in wardrobe accessed from F2; the door to F1 is not aligned with that of F2 and F1B, and the bathroom is formed by enclosing the landing at the front. The south east bay, en-suite bathroom, added in the 1930s is accessed through F1. Otherwise the first floor retains its mid-19<sup>th</sup> century plan form. All the windows to the principal rooms on the first floor retain sash windows with slim glazing bars, shutters and panelling as part of the 19<sup>th</sup> century work (Fig.62) and later work to F12 includes a sash window to the front with broader glazing bars.

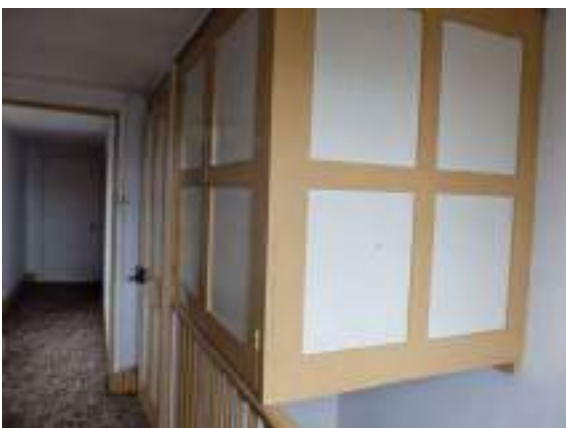
Fig.63 Attic corridor with cupboard over stairwell

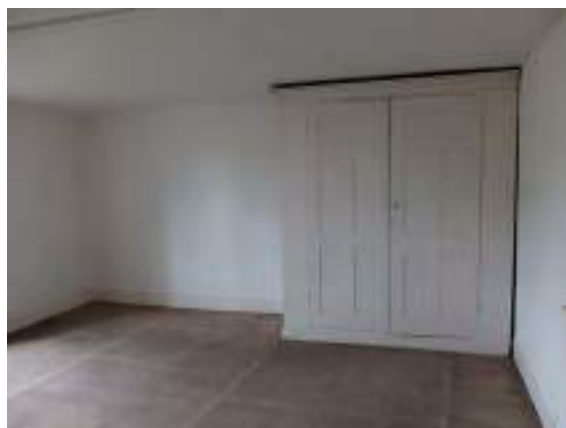
Fig.64 Housekeeper's style cupboard S2

**Second Floor:** The attic storey over the central core of the house is sub-divided into three rooms, which may not be its original configuration given the location of the window in S3 (Fig.66) and the fireplace on the east wall of S1 positioned close to the door (Fig.39). The 1780 advertisement for letting the house lists 'several good garrets' and in 1782 'six garrets' (Figs.4 and 5). The floorboards run from north to south, side to side, therefore the joists run front to back, east to west, which differs from the lower floors where the boards run east to west and the joists north to south – this is also true of the cross beams in the service range, ground floor. The pine boards on the attic storey are irregular widths which indicate an earlier date than regular width boards. Revd Risley rebuilt and extended the south end of the attic inserting the grand arched window to S2 and the fireplace on the cross wall. This allowed extensive views along the south side of the pleasure grounds which presumably was not initially for the benefit of servants who usually occupied these spaces, though the Housekeeper style built-in cupboard in S2 would suggest that it was later used as a bedroom for servants (Fig.64).

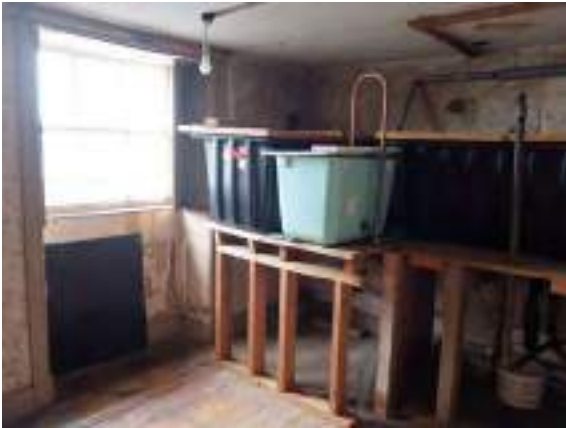
Fig.65 S3A shutters and 'garret' windows intact.

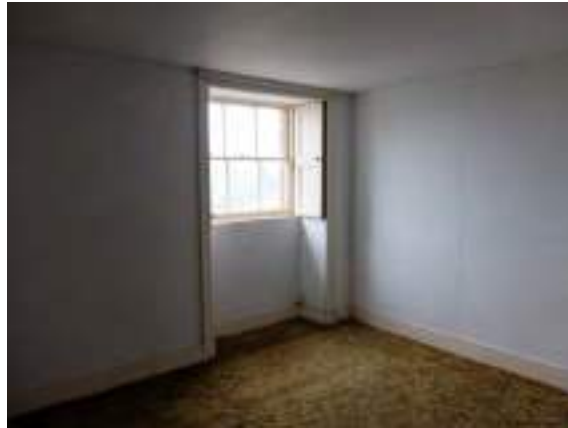
Fig. 66 Window in corner of room S3

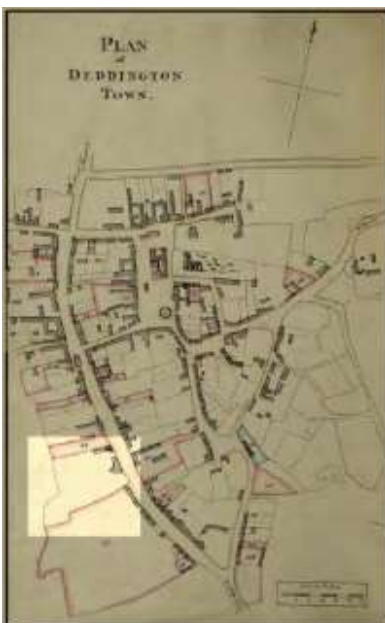
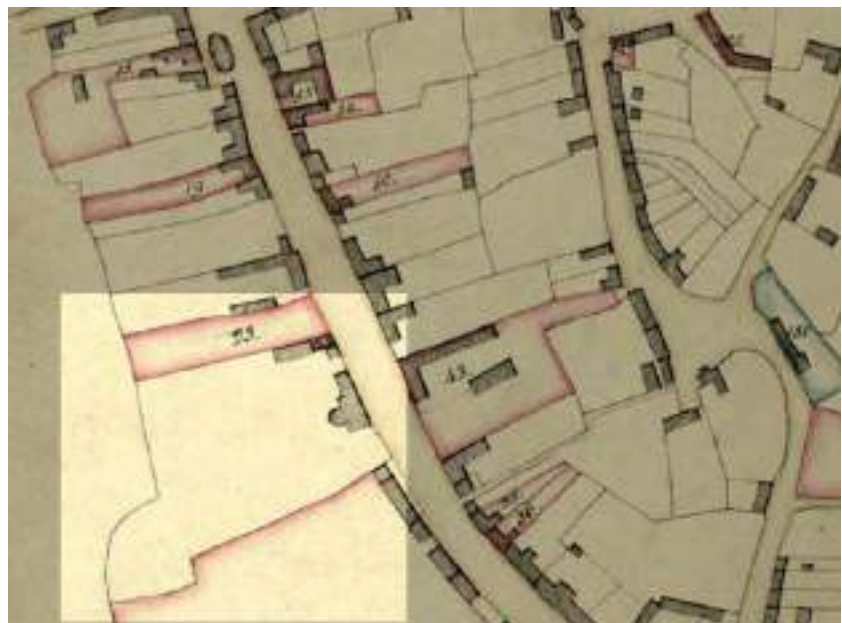
Figs.67 and 68 Plan of Deddington Town 1808

The 1808 maps show the outline of the house to include the service range on the north and a curved bay on the west elevation.

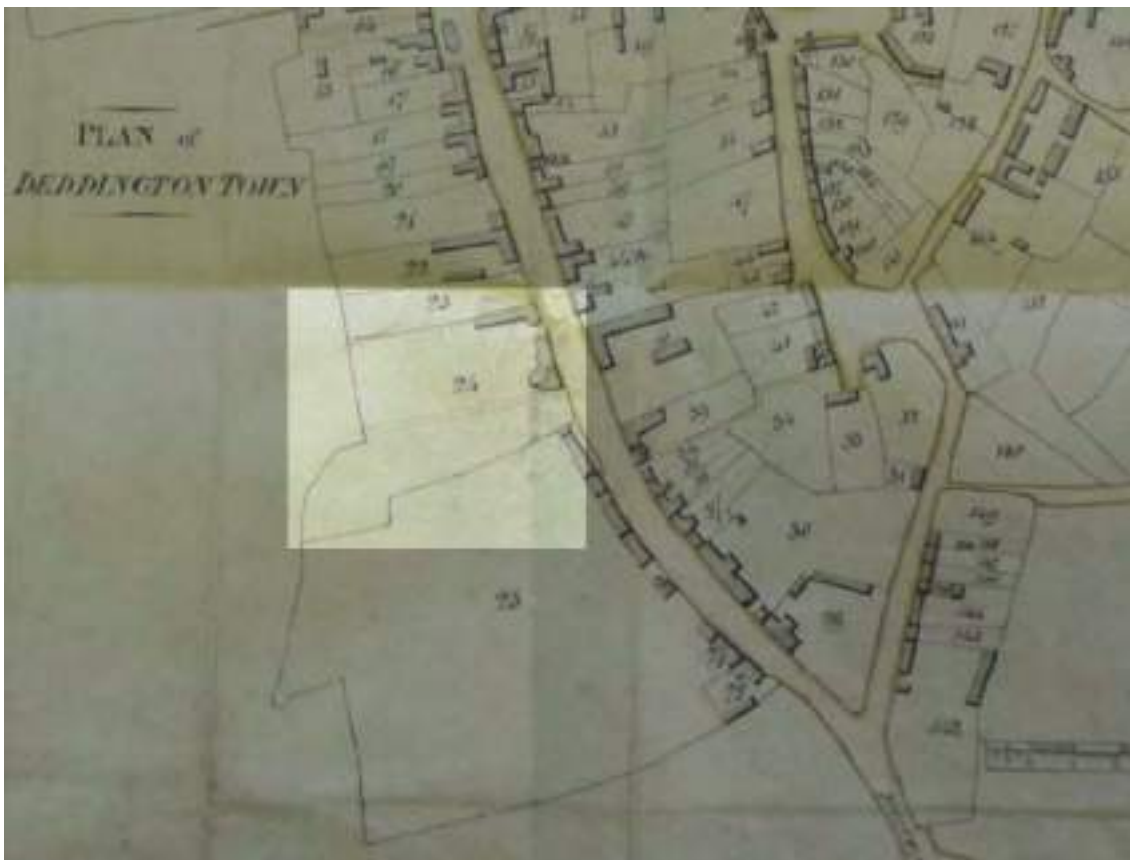
Fig.69 <https://www.deddingtonhistory.uk/maps/assets/1808enclosureaward>

Inclosure of Deddington also occurred in 1808 and the surviving plan of that year (Fig.69) shows its layout relatively unchanged since its Medieval origins and is based on the same ownership information as Cartwright's Plan but also shows who held the leases. Deddington House is described as a Homestead and Gardens (24) and the proprietor as Samuel Churchill jnr. Samuel Churchill senior holds adjoining land (22 and 23) occupied by Thomas Perkins, copyholder, and Elizabeth Hollier, copyholder of the Duchy of the Manor respectively. South of the site (25) is described as a House Garden and Orchard occupied by John Whetton as before.

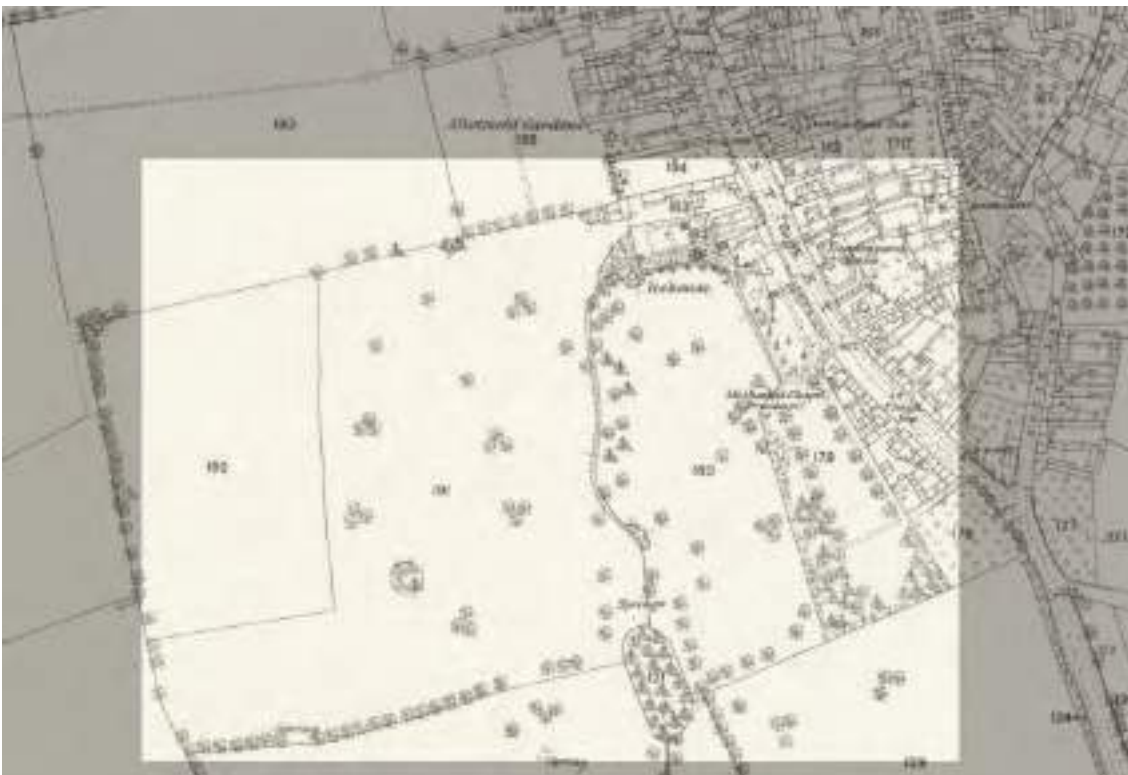
Fig.70 Oxfordshire XVI.1 Surveyed: 1880, Published: 1881 25" Reproduced with the permission of the National Library of Scotland

Cartographic sources from the late 19<sup>th</sup> century (Figs.70-73) show a few changes in the land ownership associated with the house. These were parts of the parkland distant from the house so the immediate setting remained unchanged. The 1880 map (Figs.70) shows Deddington House's demesne to include enclosures numbered 179, 180, 181, 182, 183 (Park Farm) and 191, a large field west of the house. A glasshouse/greenhouse is shown at the west end of the service range and a conservatory attached to the south west corner of the house. A small structure, perhaps a porch is shown on the south east front corner. Until the 1922 map it is shown as a separate structure and after as part of the house.

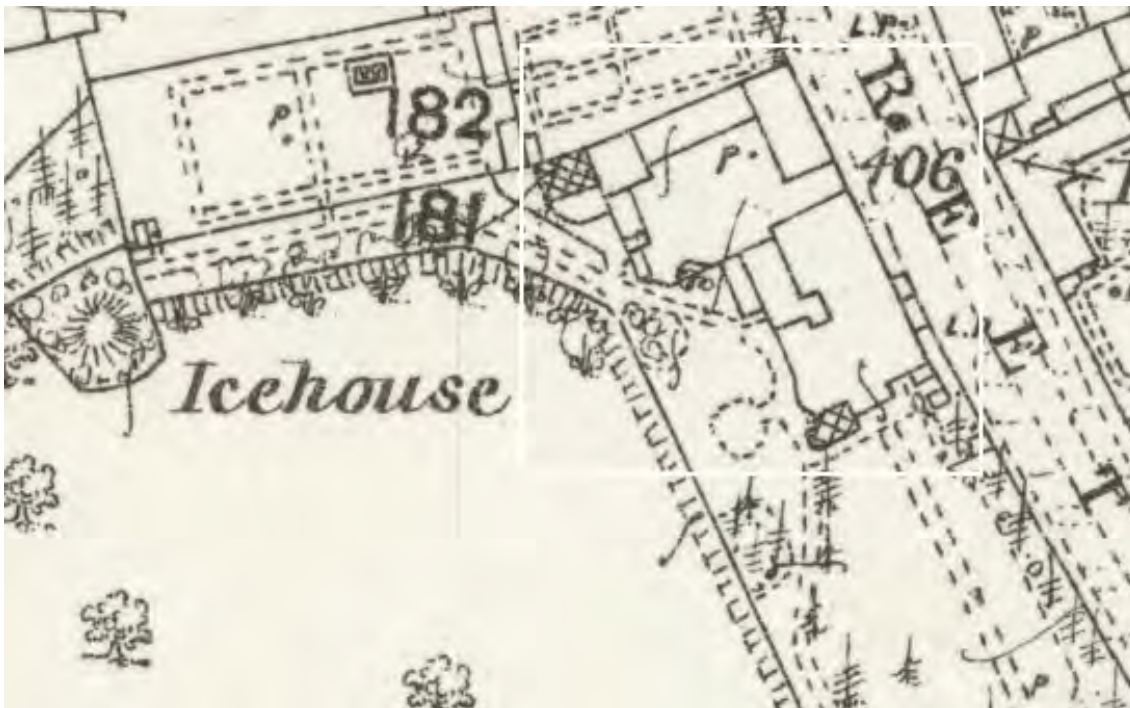
Fig.71 Oxfordshire XVI.1 Surveyed: 1880, Published: 1881 25" Reproduced with the permission of the National Library of Scotland

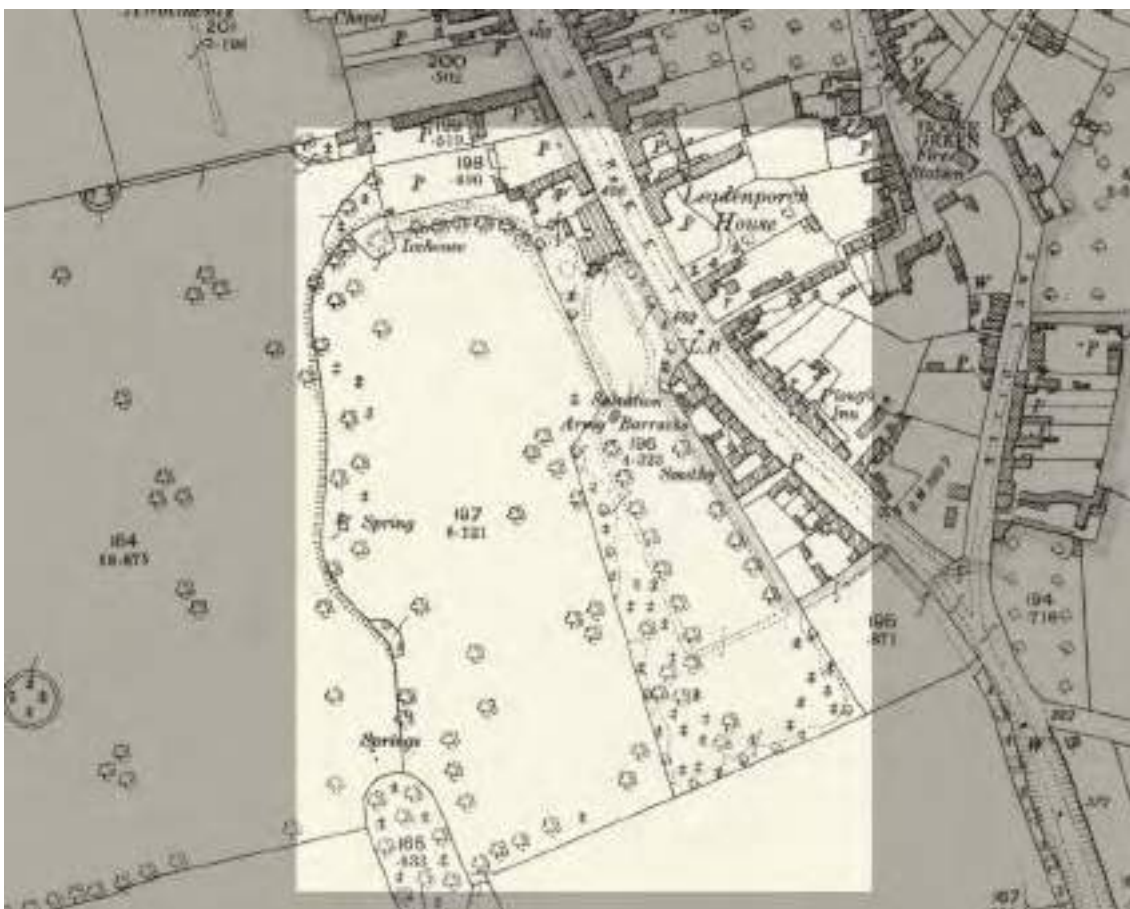
Fig.72 Oxfordshire XVI.1 Revised: 1898, Published: 1900 25" Reproduced with the permission of the National Library of Scotland

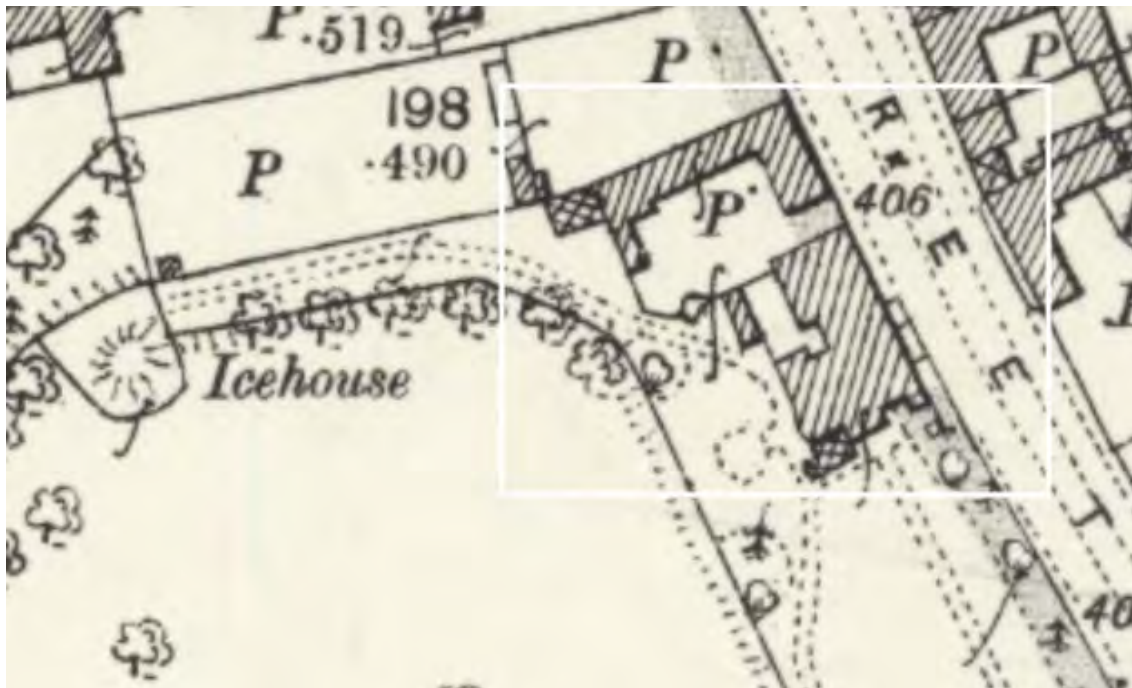
Fig.73 Oxfordshire XVI.1 Revised: 1898, Published: 1900 25" Reproduced with the permission of the National Library of Scotland

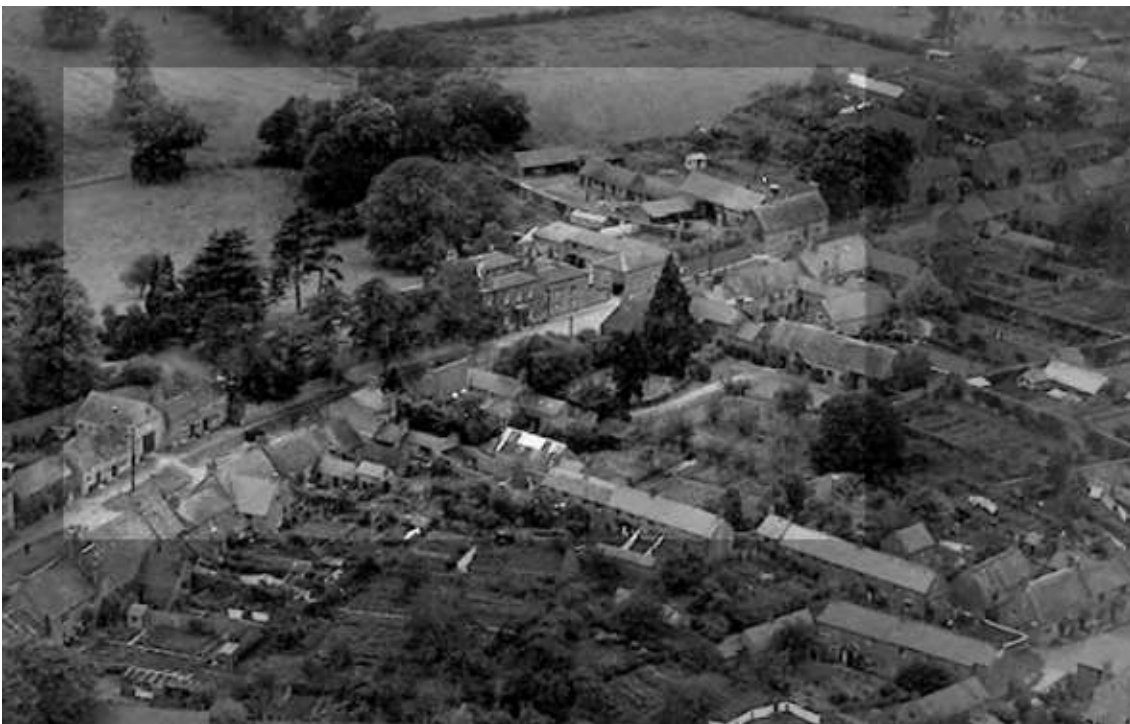
Fig.76 <https://www.deddington.org.uk/gallery/index.php/Aerial-pics/new-st-1>

Aerial views of New Street and the Manor House taken in the late 1940s (Figs.76 and 77) show a number of mature trees within the parkland and the relationship between the house and its setting unchanged.
